## Poole Park Life

Tree Survey, Arboricultural Impact Assessment and  
Tree Protection Scheme to BS5837:2012

### Appendix 5A - Planning Application March 2017

Report Reference: PPL-T-R-01  
Planning Submission

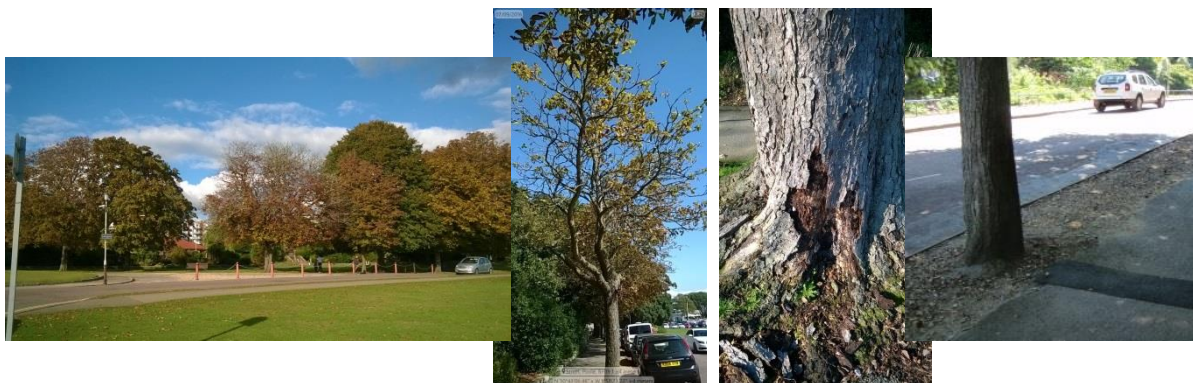
5.2.4 To add to this pressure on the avenue trees, many are affected by pests and diseases, especially as their vigour decreases. Bacterial canker (*Pseudomonas syringae* pv. *aesculi*) is evident on many of the tree stems and lower main branch structures with typical symptoms of tarry exudate (some dried from infection in previous years), bark splitting and bark death. In some cases, recovery growth may be seen where the tree is attempting to reform cambium over bare wood to produce new bark.

5.2.5 With lowered vigour and internal resources being utilised for repairing damaged bark, the trees are susceptible to secondary damage from Guignardia leaf blotch (*Guignardia aesculi*) and Horse chestnut leaf miner (HCLM) (*Cameraria ohridella*). *Guignardia* is a fungal pathogen that attacks the leaves and causes reddish or dull brown blotches with bright yellow borders around the perimeter. The blotches are usually at the tips or edges of leaves, which is not usually a problem on its own.

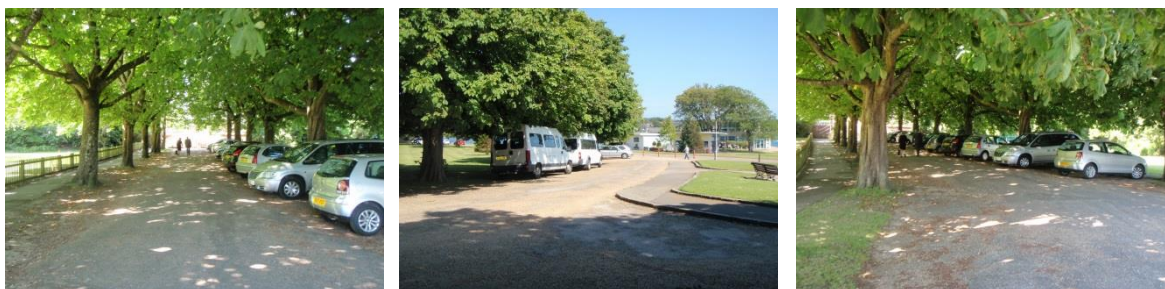
- 5.2.10 23 no. Horse chestnut trees were surveyed; 5 no. trees were classified as category 'A' trees, 16 no. trees were assessed as category 'B' and 2 no. trees were assessed as category 'U'.
- 5.2.11 A small double avenue of mature horse chestnut trees leads from the stepped entrance in Parkstone Road and splays out to the south towards the fountain (photo, below left). Originally, these trees in small verges connected with the western single avenue but several of these trees have been lost through disease over time, leaving a gap in the line of trees outside the Putting Green.

- 5.2.12 This avenue has been more successful with mature trees of roughly uniform size. This is likely to be due to the open areas of grass on either side of the trees to west and east with no competition from other trees nearby; the higher amenity grass to the west is irrigated and the trees to the east have some shelter from their companions to the west.

5.2.13 There is hard surfacing between the trees, used as *ad hoc* parking for visitors to the bowling green. At present, vehicles park between the trees and tend to drive over the verges to achieve this. Inevitably, there is compaction of the rooting zone and some damage to bark through direct contact from time to time.

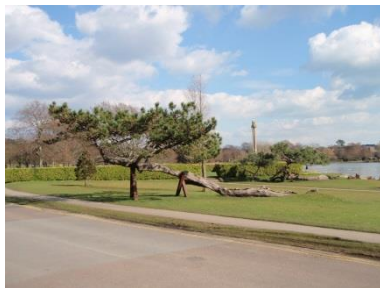
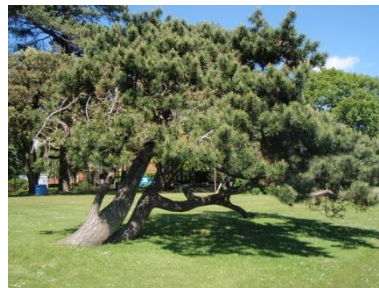
5.2.18 The area contains a number of semi-mature conifer trees near the Kitchen Restaurant and three of Poole Park's iconic leaning trees (photo below, middle). These are pine trees that are part windblown but continued growing and have been used as a play feature in recent decades.

5.2.17 Selective coppicing of the group of bay laurel has been recommended to allow rejuvenation and further planting of other ornamental species.

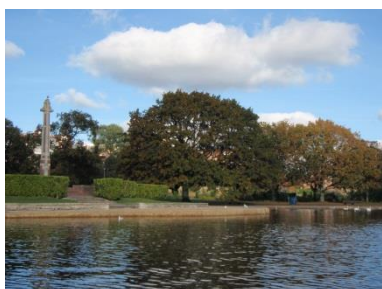
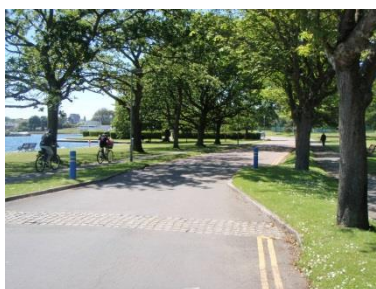
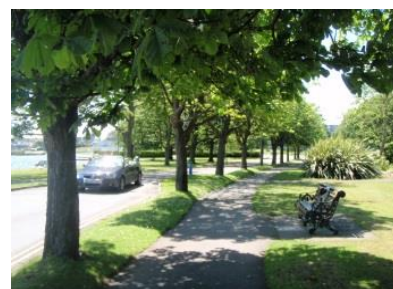
5.2.22 The line of five oaks (T142-T146) (middle photo below, trees on the left of the drive) have grown reasonably well over the years despite periods of flooding and drought, growing in a relatively shallow rooting area in consideration of the proximity to the brackish water of the lake. The Turkey oak (T145) is in poor physical condition compared to the English oaks and should be removed at this point. There is space for future crown growth of two replacement English oaks at the same location.

5.2.23 The double line of horse chestnuts leading up Middle Gate entrance is in relatively good condition. However, two trees just to the east past the junction to Whitecliff Road 2no. trees have been recommended for removal (T164 – Cat 'C' and T166 – Cat 'U').

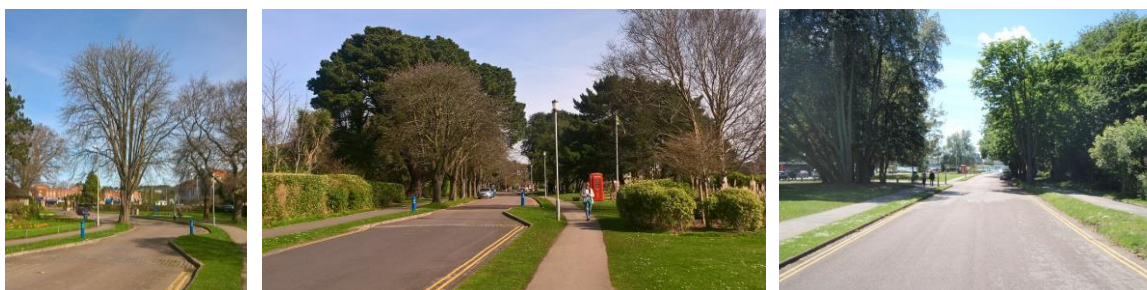
- 5.2.25 One large horse chestnut tree (T233) (Photo below, left), likely to be one of the original trees, remains isolated adjacent to the eastern entrance garden areas. Located next to an open and irrigated lawn area has allowed the tree to grow into a larger size. Being a lapsed pollard it has structural defects which require remediation work.
- 5.2.26 One large oak tree (T235) is located just to the west of the East Gate entrance. The tree is visible in historic photographs from the early years of the Park and has grown into a prominent tree which can be seen from within the Park and the surrounding highway.
- 5.2.27 Trees to the south of the Drive contain distinct groups of pine and holm oak (G9 and G10) (photo below, right) at the entrance to the Ark car park and planting of predominantly oak trees interspersed with small ornamental trees leading up to East Gate entrance.

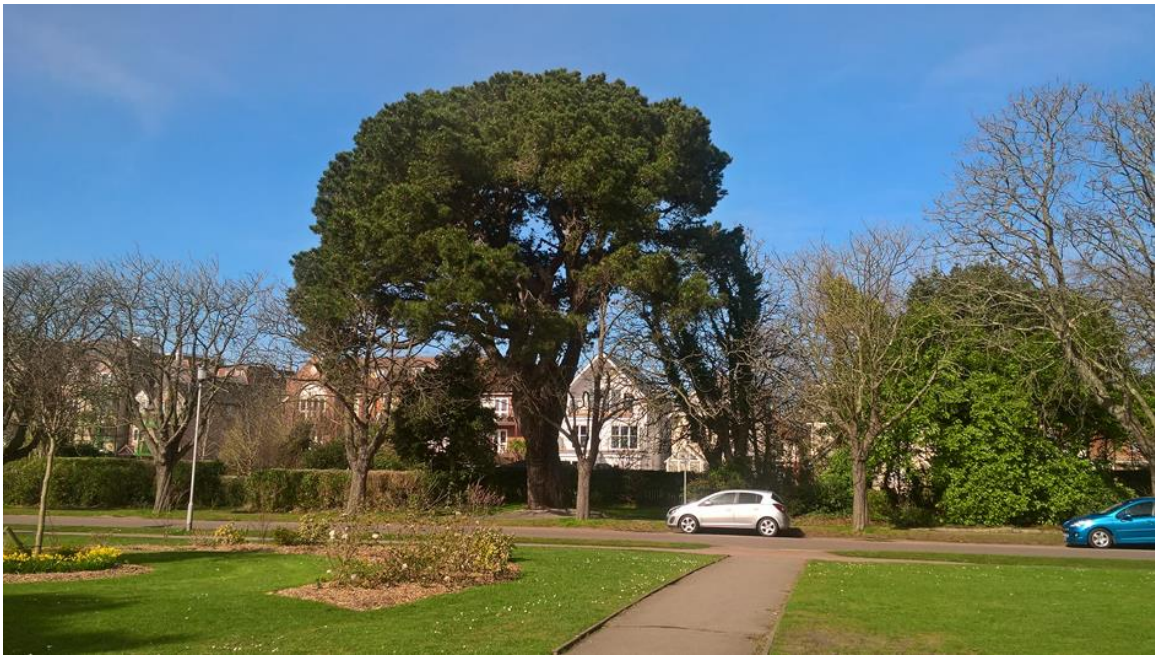
- 5.2.31 Monterey Pine (T182) (photo below) is situated along the boundary opposite the Ark Café. This is a locally notable tree of nearly 5 metres in girth. It is estimated that the tree is around 150 years of age. The tree has a large canopy and is visible from some distance away. Over time, the tree canopy has expanded over the horse chestnut avenue causing suppression of these trees to the point where they are now not worth retaining.

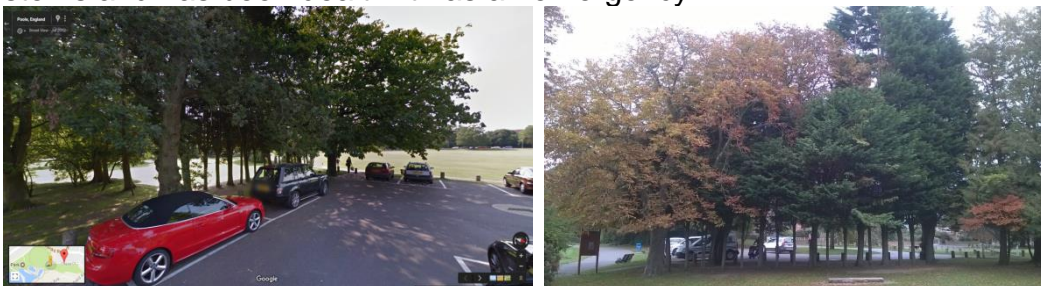
- 5.2.31 This small parking area on the east side of the Park has a number of maturing and mature specimen trees surrounding it (11 no. trees, including 10 no. category A and 1 no. category 'B'). There is a lapsed hedge consisting of leyland cypresses (G12), category 'C', to the south of the car park. Multiple upright branching growths indicate that this line of conifers was originally maintained at about two metres (Photos, below)). Weak branch attachments are evident; a branch has snapped out recently from one of the larger tree stems and has been dealt with as an emergency.

5.2.32 There are several mature tree species in the immediate vicinity which have part of their root zones covered with hard surfacing, extending relatively closely to the tree stems. Removal of this line of lapsed hedging would benefit the long term health of these mature trees by reducing competition for resources. The relative amenity loss is considered to be low.

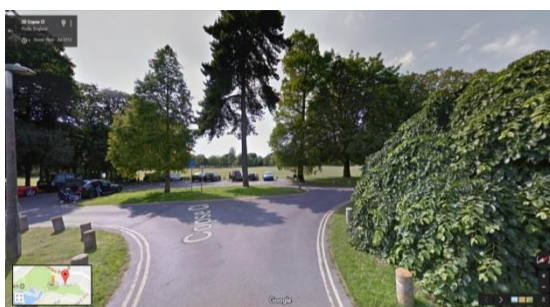
5.2.33 There are two trees (T286 & T287) on the island in the car park (Photo below) which should have more permanent protection for their root zones. There is evidence that vehicles are turning, especially when the car park is busy and using the island as turning space, impinging on the RPAs of the trees in situ and causing root damage through compaction.

- Provision of individual mulched circles and larger contained areas of mulching to existing trees to improve growing conditions.
- Provision of raised kerb edging and cut stone blocks to serve as vehicle barriers for the trees in the grassed island of the Copse Close car parking area.

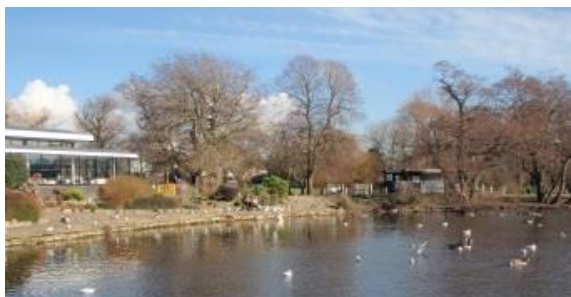
5.2.34 29 no. trees and 2 no. groups have been surveyed along the banks of the Freshwater Lakes and the island on the small Freshwater Lake. Species contain a large proportion of oak and willow trees which appear to thrive in the wet ground conditions. The area generally contains a number of dead or dying alders. An initial assessment carried out by the Forestry Commission in December 2016 indicated the potential presence of Phytophthora (Alder dieback disease).

5.2.35 Vegetation of G13 and G14 has received little management in the past years and requires selective clearing, coppicing and replanting to rejuvenate.
