VICTORIAN BUILDINGS IN POOLE PARK

THE BRICK AND TERRACOTTA STRUCTURES WITHIN POOLE PARK

*CONSERVATION CONDITION SURVEY, REPORT AND
RECOMMENDATIONS FOR CARE*

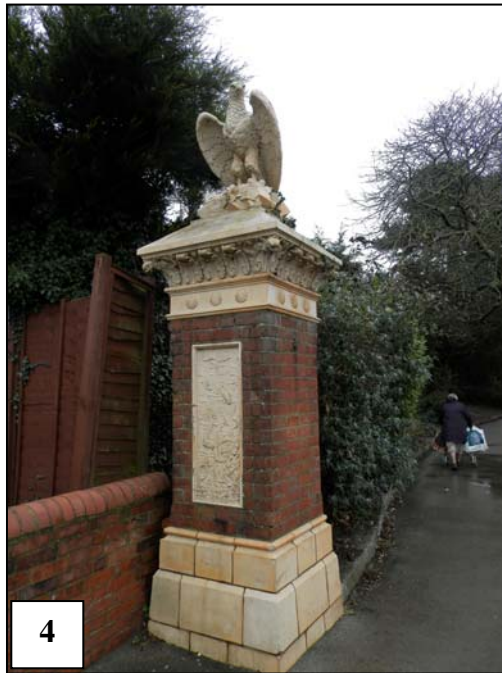
4. NORTHERNMOST PIER
5. SOUTHERNMOST PIER SHOWING SMALL (REDUNDANT) PLAQUE ON LOWER BRICKWORK
6. IVY GROWTH AROUND THE CAPSTONE OF NORTHERNMOST PIER
7. HOLE AND PERIPHERAL DAMAGE ON PLINTH OF SOUTHERNMOST PIER

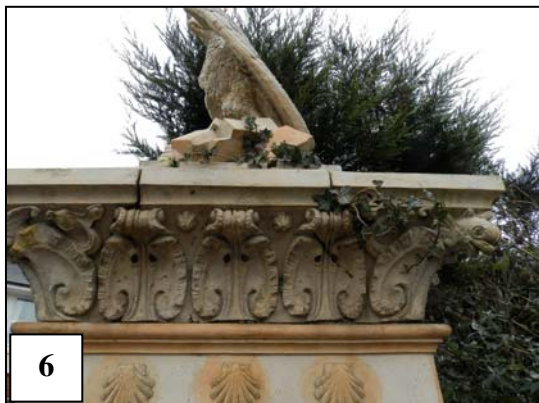
The piers are in relatively good condition, possibly because of their orientation away from direct contact with either heavy traffic or the sea. The construction of the capstones in four sections has resulted in perpendicular joints that have been susceptible to weathering and there is some loss of pointing (which may have been a cementitious material) Holes remain in the plinth blocks where (railings?) may have originally been located. There is ivy growth on the more northerly pier which, although it appears not to have invaded joints in the capstone, may, if left, cause future damage. A small plaque (purpose indecipherable) has been screwed to the brick face of the southerly pier. There are the remains of original gate ironwork protruding from the brickwork which do not appear to be causing expansion damage as a result of oxidation.

Although visually inoffensive, the ivy should be removed. Not all species cause damage to building materials but jacking open of joints on the capstone may occur if growth continues. Some minimal lime mortar re-pointing to the ceramic detailing would be prudent and consideration should be given to the removal of the redundant plaque and the filling of plug holes with lime mortar to match the brickwork. The unsightly hole in the plinth of the S pier should be repaired with matching mortar. The protruding hinge ironwork is the visible part of a large Y shaped fixing, bedded deep within the core of the pier. These protrusions should be carefully treated with a rust inhibitor but otherwise should be left undisturbed.

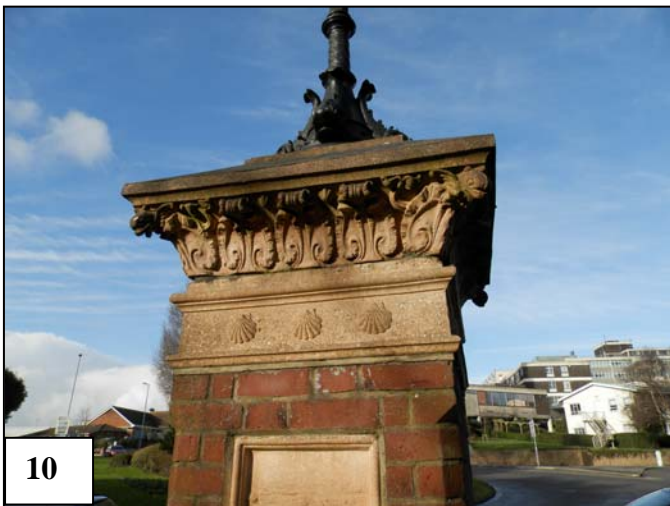
10

Being cast ceramics, the eagles have weathered well and are comparable to the originals at the other entrance gates. The composite material has weathered less well, the dyes used in the concrete to simulate the terracotta have discoloured in many places, resulting in a pinkish hue. The coarse open texture of the concrete plinth blocks has attracted pollutants and biotic growth.

- 8. STEPS FROM THE GATE TO THE PARK LEVEL
- 9. THE FIVE PIERS COMPLIMENT THE OTHER ORIGINAL GATES WELL
- 10. MUCH OF THE COMPOSITE CAST MATERIAL HAS DEVELOPED AN UNFORTUNATE PINK BLOOM
- 11. UNSIGHTLY MOSS ACCUMULATION AND OPEN JOINTS ON THE CAPSTONES

Being only 25 years old, these piers are in relatively sound condition. Some gentle cleaning to remove moss growth on the capstones and discolouration of the plinths, coupled with a biocidal treatment might be considered. The new construction of the capstones has resulted in fewer vulnerable perpendicular joints but some re-pointing may be necessary.

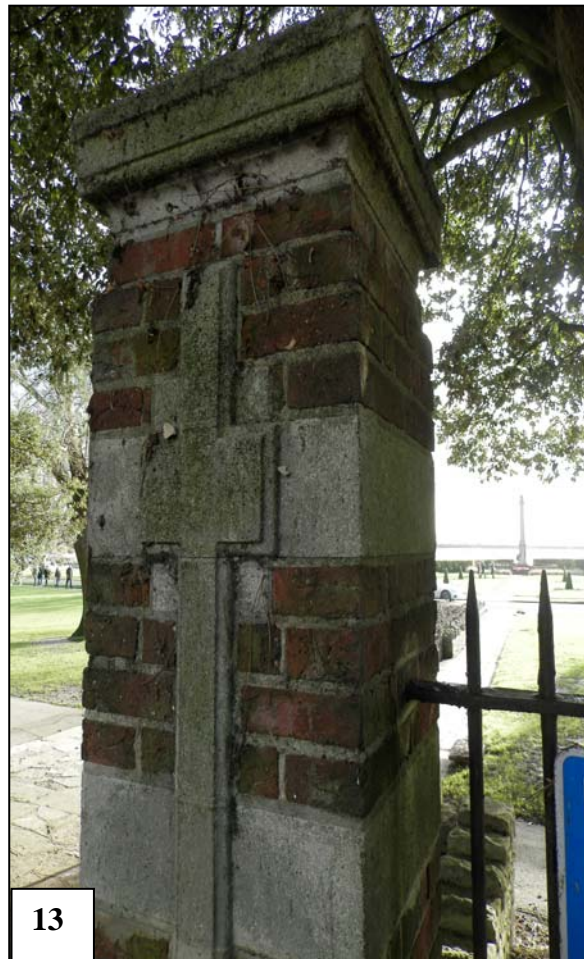
13

Structurally sound, the piers have suffered mainly from the dulling effect of biotic growth and low level pollutants, due partly to their position underneath the adjacent trees and their proximity to the busy road. The Purbeck stone, being naturally coarse in texture, has accentuated this discolouration. There is evidence of some ivy growth on the piers.

- 12. CENTRAL PIERS AND IRON GATES
- 13. BIOTIC GROWTH ON CENTRAL PIER

From a conservation stance, the piers require minimal intervention. Consideration could be given to a cleaning programme involving Doff or Thermatech superheated steam systems, combined with a benign biocidal treatment (thorough trials should be undertaken to safeguard the substrate material). Appropriate paint treatment of the ironwork would enhance the entrance in general.

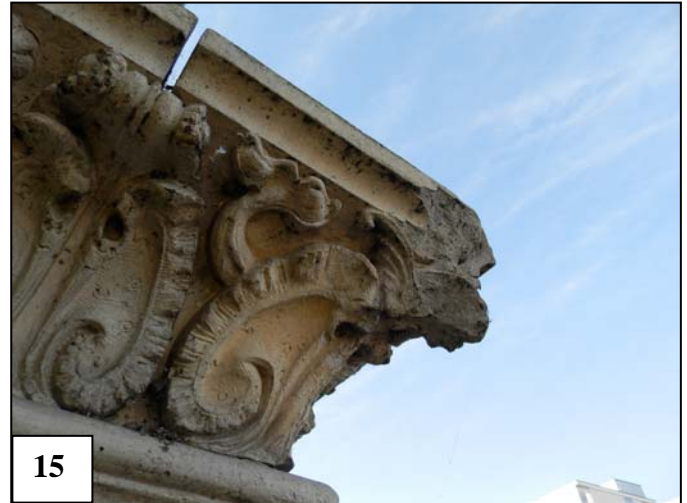
At first glance the piers seem to be in reasonable condition. Despite the turfed area extending to and nearly surrounding the bases, there is limited discolouration from biotic growth, although the most westerly pier is succumbing to ivy invasion because of its proximity to the hedging/shrubbery. There has been previous re-pointing of the brickwork with a cement mortar which, although not causing serious salt decay to the adjacent bricks, is unsightly. There is some damage/loss of material to the terracotta detailing both on the plinth blocks and the capstone decoration. Joints on the capstone have suffered from loss of pointing material. Several of the cast iron hinge and bracket (sic) fixings have been left in situ, some have been cut off flush to the brickwork (presumably to avoid injury to pedestrian users of the centre opening).

- 14. MIDDLE GATE VIEWED FROM PARKSTONE ROAD
- 15. DAMAGE TO THE CORNER OF THE TERRACOTTA DETAILING AND LOSS OF POINTING MORTAR ON THE CAPSTONE
- 16. DAMAGE TO THE MOULDINGS ON THE TERRACOTTA PLINTH BLOCKS
- 17. INVASIVE IVY ON THE WESTERNMOST PIER

Initial work should involve the re-pointing of the perpendicular capstone joints to reduce potential water ingress. Damage to the terracotta detailing could be repaired using a hydraulic lime mortar on armatures, mixed to colour match the substrate material. There is a reasonable case for the removal of the cement pointing on the brickwork and its replacement with a suitable lime mortar but extreme care would need to be taken to avoid damaging the bricks in the process. All remaining iron work should be cleaned and treated with a rust inhibitor but left in situ if deemed to be non hazardous to the public. Consideration should be given to the removal of turf from, and paving of, the areas on the Park side of the piers. This would reduce the risk of water saturation around the bases, it would reduce the risk of damage from grass cutting/trimming equipment and may enhance the piers' appearance. Limited biocidal cleaning could be considered.

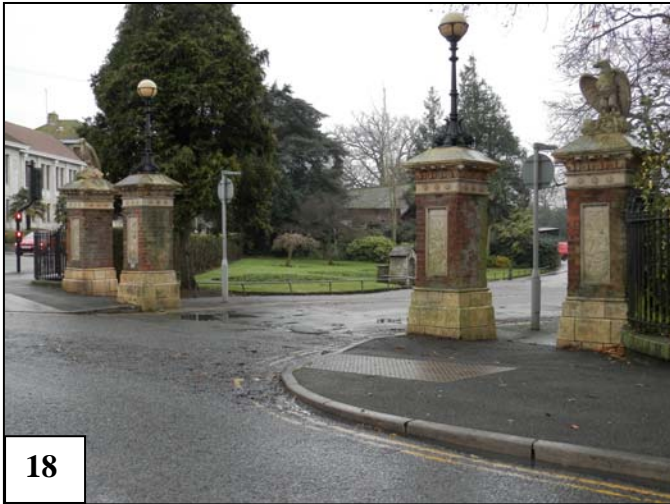
- 18. THE IMPACT OF THE EAST GATES IS SLIGHTLY OVER SHADOWED BY THE 'NO ENTRY' SIGNAGE ON THE PARK SIDE OF THE ENTRANCE
- 19. PLANT GROWTH ON AND CORNER DAMAGE TO THE TERRACOTTA CAPSTONES
- 20. LOSS OF MORTAR IN THE PLINTH JOINTS
- 21. HORIZONTAL CRACK ACROSS TERRACOTTA SEALIFE PANEL

The East gate suffers from its role as a primary entrance to the park and this is reflected in the proliferation of signage (fixed and temporary) around it. Metal signs should not be lent against the brickwork and care should be exercised when inserting and removing the traffic bollards to avoid damage to the pier plinths.

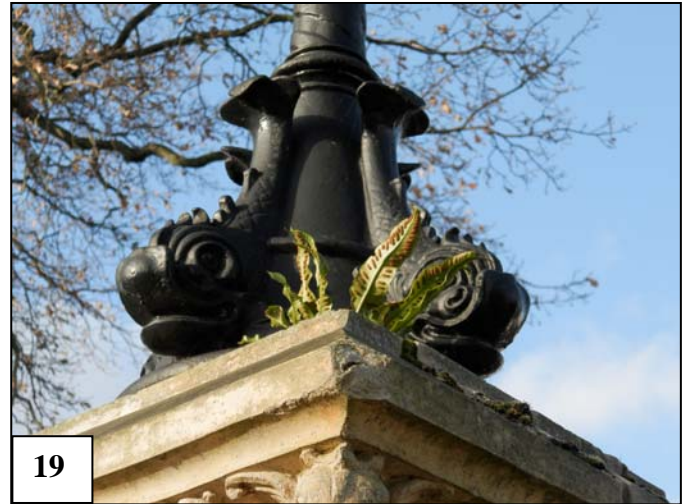
The piers are suffering from a low level discolouration, mainly due to lichen and algae growth but also as a result of their proximity to heavy traffic flow. A considerable amount of joint mortar has been lost both from the plinth blocks and the capstones. As on the Middle Gate piers, previous cement re-pointing is inappropriate, unsightly and in areas, failing. There is damage to the terracotta moulding on the decorative band below the several of the capstones and to detailing on the corners of the capstones themselves. Previous unsightly (cementitious) repair has been carried out to areas of damage on the plinth blocks. There is a distinct horizontal crack across the terracotta 'sealife' panel on the Park elevation of the inner east pier. Over the years, a haphazard approach to retaining or removing the redundant iron fixings has resulted in a variety of random shapes protruding from the brickwork. Considerable plant growth has established itself around the base of the lampposts and encroaching shrubbery may further disrupt/discolour the outer two piers.

Although the lichen biotic growth is not particularly threatening, all the piers would benefit from a low level clean (primarily with low pressure water spray and brush) to highlight the terracotta detailing. The plant growth around the lampposts should be removed and any stubborn root growth treated with a weedkiller. Consideration should be given to the removal of areas of cement pointing mortar and replacement with a lime based equivalent (naturally hydraulic lime mortar for low level or weathering surfaces). All damage to terracotta work should be addressed with plastic repair using a hydraulic lime mortar on fired clay armatures and the crack in the 'sealife' panel made good with the same mortar. A decision should be made on the retention or reduction in size of the remaining iron fixings and they should, if necessary, then be 'trimmed' with hand held hack saws, cleaned and treated with inhibitor. No attempt should be made to remove them completely.

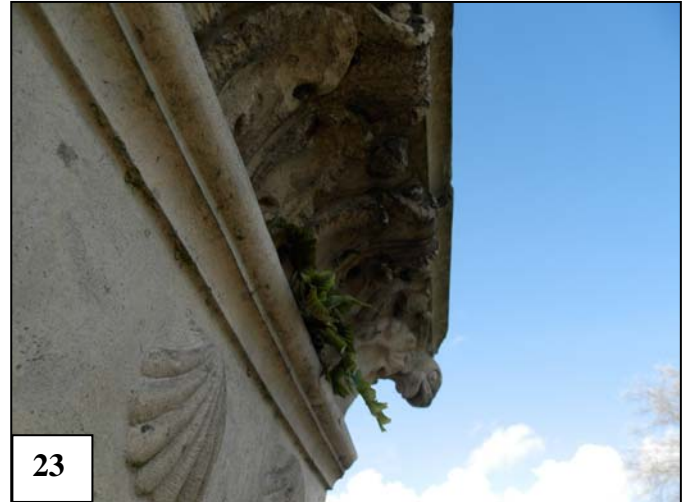
Despite their close proximity to the salt water of the boating lake, the gate piers show little evidence of salt decay in the brickwork. As with the other gates, loss of jointing mortar is an issue, both on the ceramic work and in parts of the brickwork. There is evidence that the narrow carriageways have resulted in damage to the plinth blocks from vehicle impact. Marine environment plants have rooted themselves around some of the capstones and there is lichen growth on some of the capstone pieces. The remaining ironwork is, as with the other gates, random and without any obvious reference to its original purpose. The C20th work obviously substituted different materials for a number of elements – although there appear to be original ceramic sections alongside recent replacement terracotta pieces - resulting in something of a patchwork effect in some of the detailing. Other composite (concrete) replacements are of a very different texture and mineral composition to the remaining original terracotta work, resulting in mineral discolouration and the accumulation of pollutants in their more porous surfaces.

22. VIEW FROM THE SOUTH, SHOWING THE NOW REBUILT WESTERNMOST PIER
 23. PLANT GROWTH ESTABLISHED IN THE CAPSTONE JOINTING
 24 AND 25. CLEAR VISUAL DISCREPANCY BETWEEN REPLACEMENT TERRACOTTA AND CAST CONCRETE/COMPOSITE ELEMENTS

Re-pointing of failed joints and inappropriate mortar should be carried out. Some repair work to the terracotta could be undertaken. Plant and growth removal with appropriate biocidal treatment is recommended. Consideration should be given to restricting vehicle speed through the entrances to minimise the risk of minor collision with the piers. Unfortunately the options for minimising the discordant appearance of the former restorative work are limited and it should be viewed as honest evidence of these previous interventions.

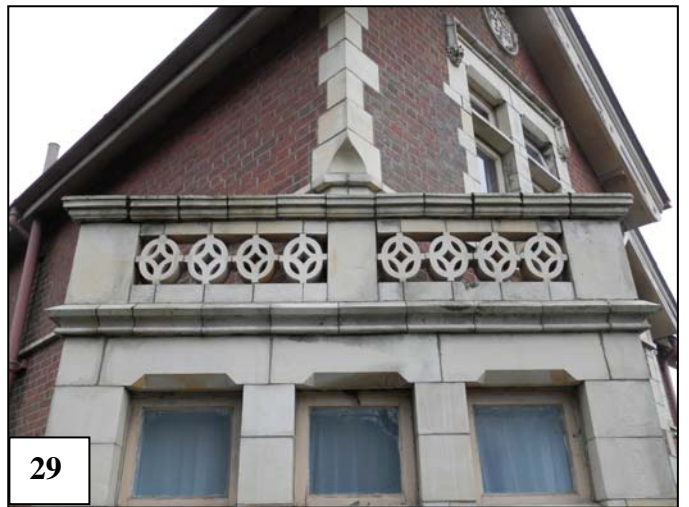
Overall, the lodge appears to be in relatively sound condition (this report cannot attest to its structural integrity). The most significant details (the commemorative plaque and the armorial) are in good condition with no damage or staining. There is disruption and loss of bedding and pointing mortar on the joints of the corner bay parapet, the SW corner quoins and the stable yard gate piers. There is no visible evidence of settlement, jacking or stress in the former, in the case of the latter there is evidence of vehicle damage to the glazed brickwork plinth and plant growth disruption around the capstone. There is some plant growth from the base of the N chimney pots. The south gable elevation has relatively recently been re-pointed with a cement mortar that appears to be performing well. An unsightly void and radiating cracking in one of the SW quoins has possibly been caused by the past insertion of a ferrous? fixing.

- 26. WEST ELEVATION OF THE LODGE
- 27. ARMORIAL ROUNDEL ON THE SOUTH ELEVATION
- 28. TERRACOTTA STIFF LEAF LABEL STOP
- 29. PARAPET OVER CORNER BAY SHOWING OPEN PERPENDICULAR JOINTS BETWEEN COPINGS

Removal of any failed pointing and re-pointing with an appropriate lime mortar (see Specifications Section 15). Any plant growth should be removed and any inaccessible root systems treated with systemic weedkiller. The caps and finials on the stableyard gate piers should be checked for stability. Loose elements should be removed, cleaned and re-set in lime mortar. The parapet above the corner bay should also be checked for stability and loose elements re-set as above. Any holes/excavations in the terracotta work should be filled with colour matched mortar. Re-decoration of the cast iron rainwater goods and timber elements would benefit the appearance of the building and help prolong their integrity and that of the surrounding materials.

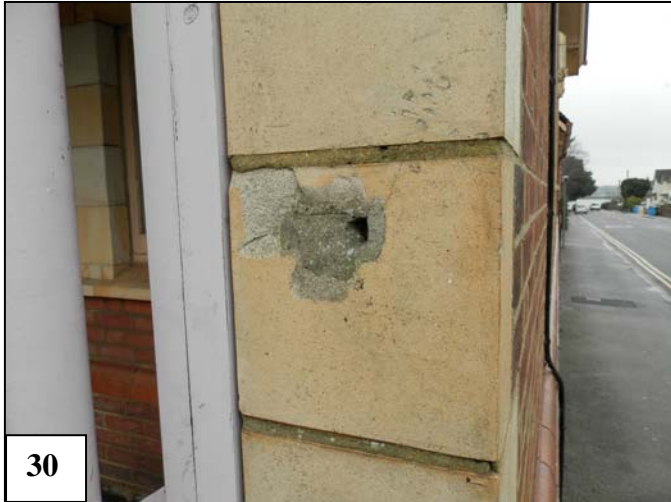
- 30. HOLE LEFT BY PREVIOUS FIXING IN TERRACOTTA QUOIN (SW CORNER)
- 31. PLANT GROWTH ON NORTHERNMOST CHIMNEY STACK
- 32. DISRUPTION TO CAPSTONE ON STABLEYARD GATE PIER
- 33. VEHICLE? DAMAGE TO PLINTH ON STABLEYARD GATE PIER

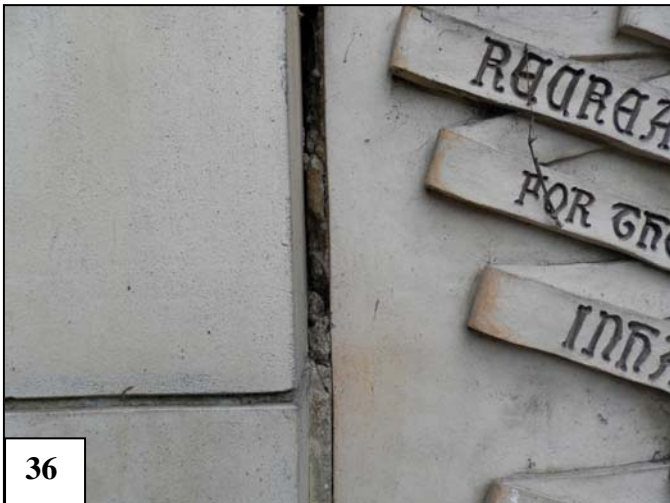
The building is in relatively good condition and has been by no means neglected. It has however been allowed to shrink from prominence, mainly because of unsympathetic alteration and, currently, excessive plant growth around the east and north elevations (the inscription panel is almost obscured from view). Dense growth around the canted bay window and soil levels rising above the air bricks may prevent adequate ventilation and impede drainage away from the walls (ivy, although not directly harmful to the brick surfaces, can invade joints where pointing has failed or between timberwork and eventually cause expansion damage). There is loss of facing on many of the (newer) bricks on the west extension. There is unsightly damage to the weathering underside of the terracotta sill on the south window (due perhaps to frost or impact). On the north elevation some of the terracotta plinth weathering course is missing. There is considerable loss of mortar around the joints of the inscription panel and the surrounding window and some slight cracking to the surface of the panel itself. Jointing between the timber window frames and the terracotta surrounds has failed in some windows and been replaced by scrunched up paper. The rainwater goods appear in good condition. Paint work on the soffits is badly deteriorated with extensive blistering and peeling. There is some slight distortion of the leaded lights on the bay windows.

- 34. VIEW FROM THE SOUTHEAST
- 35. NORTH ELEVATION WINDOW AND COMMEMORATIVE INSCRIPTION PANEL
- 36. FAILED MORTAR IN JOINTS AROUND THE INSCRIPTION PANEL
- 37. SUBTLE USE OF PAPER AROUND WINDOW FRAMES
- 38. DAMAGE TO WINDOW SILL ON SOUTH ELEVATION
- 39. EXCESSIVE PLANT GROWTH AROUND CANTED BAY WINDOW

A programme of re-pointing all failed joints should be considered. Damaged bricks and terracotta work would benefit from limited repair in matching lime mortar. Plant growth around the north elevation and underneath the east bay window should be cut back, the soil level lowered and appropriate drainage considered. Some care should be taken to clean and repair the fine cracking on the inscription panel and consideration given to clearing the plants obscuring it from view. A programme of paint re-decoration should be considered for the timber elements including window frames, soffits and corbelled brackets around the canted bay.

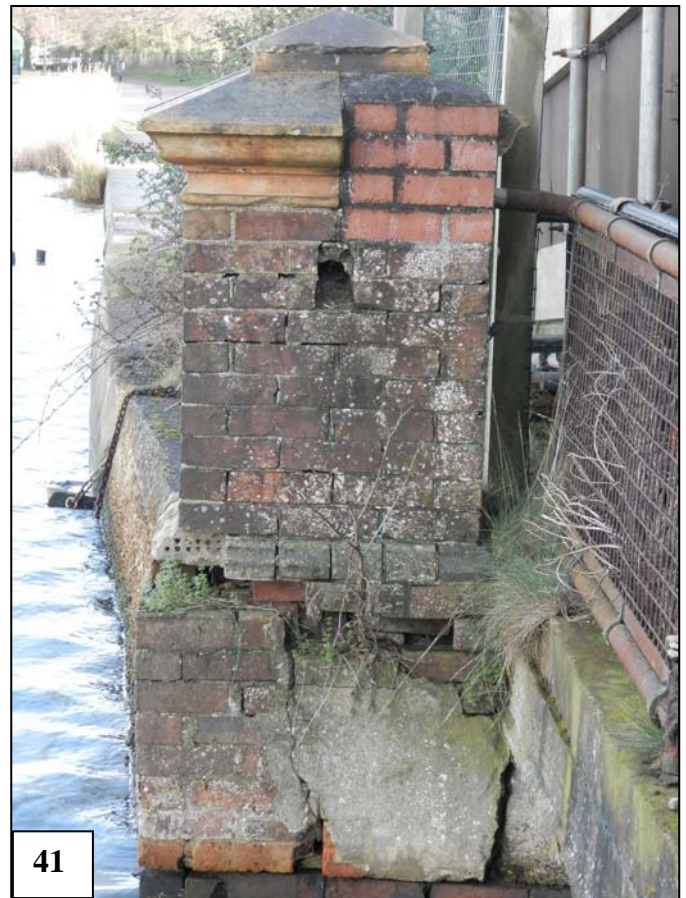
The piers are in poor cosmetic condition and may have some structural issues. Their appearance is not enhanced by the unappealing railings of the footbridge behind and the overgrown banks and old fencing to the sides. There is considerable loss of jointing mortar on both, especially at lower (water) levels and some missing and loose bricks on the easternmost pier. Concrete rendering at water level is cracked and may be detaching. Original hinge locations are now unsightly holes. The cappings on each consist of five sections and pointing has failed on most joints allowing water ingress to the core. One section of capping on the east pier is missing and has been replaced with a completely mismatched brick and render repair (which does appear to be structurally sound). There is considerable plant growth around both piers and it is likely that root systems have invaded the cores of both.

41. THE EAST PIER SHOWING MISSING CAPSTONE, FAILED AND MISSING BRICKWORK AND DAMAGED WATERLINE RENDER

More investigation into the integrity of the piers is advisable. The loss of the gates themselves has probably lessened the stresses imposed but repair work should only proceed if the piers are deemed to be structurally sound. All plant growth should be removed and the piers treated thoroughly with an (environmentally suitable) biocide. Repair or replacement of render and pointing at and below water level should be carried out using a natural cement. Other failed brick work mortar should be re-pointed with an eminently hydraulic lime mortar (NHL 5). The capstones should be re-pointed and cleaned and consideration should be given to replacing the missing section on the east pier with either a cast ceramic or stone substitute. A comprehensive risk assessment must be undertaken before any further work on the piers.

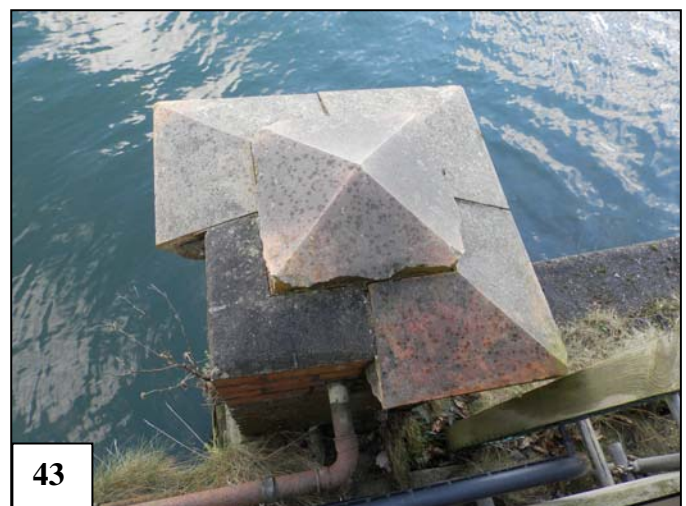
43. THE EAST PIER CAPPING SHOWING THE MISSING SECTION

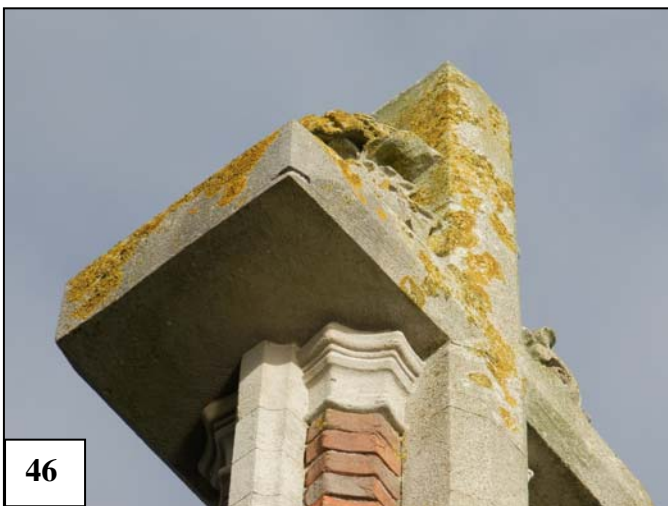
The Memorial obelisk is in reasonable condition given the coastal environment. There is some slight loss of pointing mortar on the brick work (mainly at the corner arrises) and on a few of the stone joints. As would be expected there is little pollutant staining but there is considerable lichen growth on the stonework at the top of the cross, where there also appears to be a slight area of damage to the end of the west horizontal member. There is a severe fissure across the north of the brick terrace, the hard cement grouting/pointing causing the bricks as well as the joints to crack. This may be due to some slight settlement but there is nothing to indicate major disruption. A smaller fracture can be seen just to the south of the podium steps. The brickwork around the Memorial is in reasonable condition but there are some areas of lost pointing. The flag and crazed paving is unsightly but not in poor condition.

- 44. VIEW FROM THE SOUTH (LAKESIDE)
- 45. VIEW FROM THE NORTH (INSIDE THE MEMORIAL GATES)
- 46. LICHEN BUILD-UP AROUND THE TOP OF THE CROSS (SLIGHT STONE DAMAGE ALSO VISIBLE)
- 47. CRACKING ACROSS THE BRICK TERRACE (NORTH END)

Normally one would advocate as little invasive cleaning as possible and the Memorial is not greatly stained or discoloured but it may benefit from a benign steam based cleaning programme such as the Thermotech or Doff processes. This would remove the unsightly lichen and restore brightness to the Purbeck stone. Limited re-pointing should be undertaken to the obelisk shaft and cross with care taken not to damage brick and stone arrises during the removal of old mortar. Any damage to the Purbeck stone should be repaired using a matching hydraulic lime mortar. The brick terrace may also benefit from cleaning using the same steam based method as the cross and again careful re-pointing is recommended. Any fractured bricks should be removed and replaced with a durable and suitable match. It is not within the scope of this report to advise on the aesthetic of the subject but it is debatable whether the landscaping around the Memorial suitably enhances its intended impact.

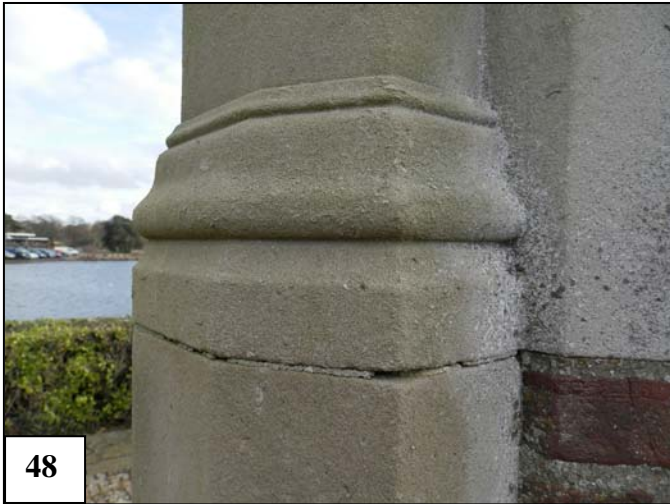
- 48. SLIGHT LOSS OF POINTING ON PURBECK STONWORK
- 49. OPEN JOINT BETWEEN BRICK SHAFT AND STONE CROSS
- 50. CORNER EROSION OF POINTING
- 51. CRACKING AND LOSS OF POINTING TO THE SOUTH OF THE MEMORIAL BASE

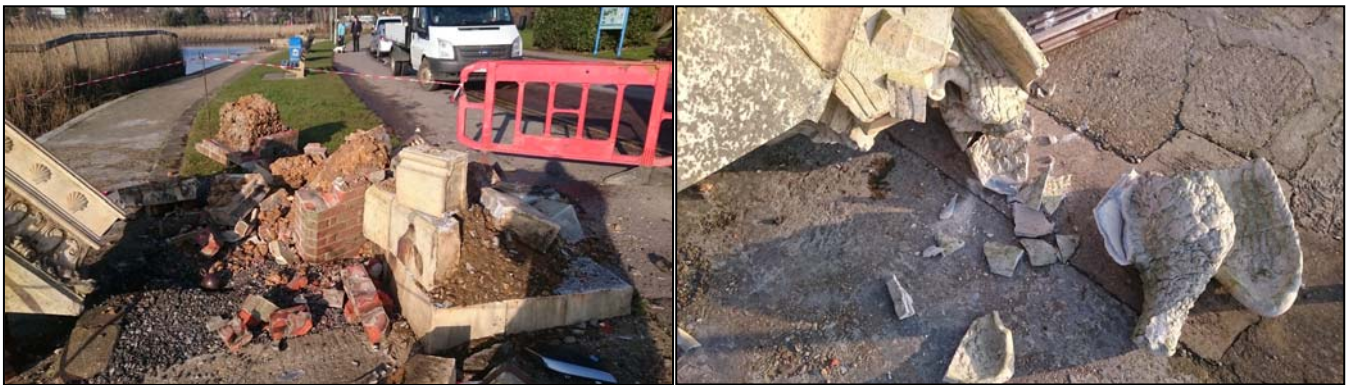
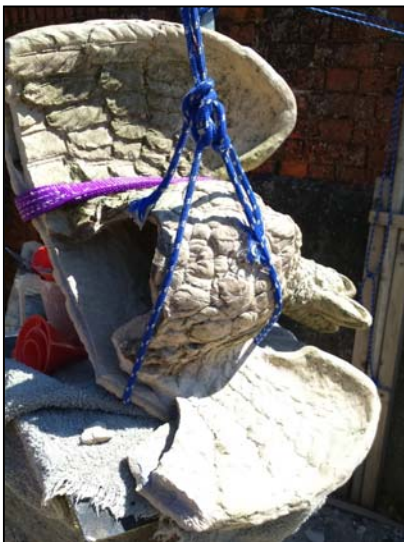
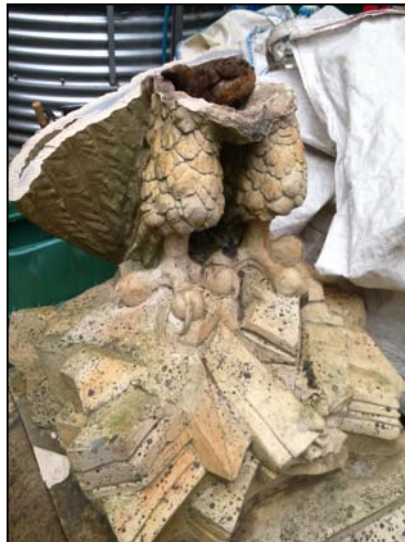
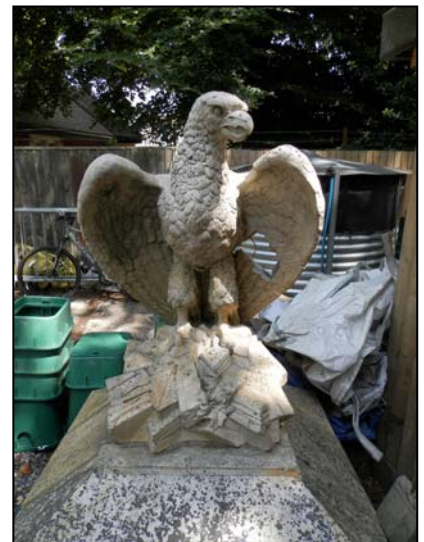
The pier was demolished when struck by a vehicle at the beginning of 2015. Prompt action meant that Parks staff managed to retrieve a large amount of material including the bulk of the eagle fragments, some of which had been thrown into the boating lake

All but four of the plinth sections, large ceramic blocks, were dislodged. Four of the twenty four blocks were damaged beyond repair.

One of the two ceramic seascape panels was completely fractured, the other remained intact with a horizontal hairline crack across the centre.

ABOVE; THE REMAINS OF THE PIER IMMEDIATELY AFTER IMPACT, THE SHATTERED EAGLE, PRIOR TO GROUT FILLING, THE REMAINS OFF THE EAGLE ON THE CAPSTONE, RECONSTRUCTION NEARING COMPLETION

The principal issue with the eagle was the left wing which was shattered into over a dozen pieces. These were carefully cleaned and gradually pieced together using stone resin adhesive, with small stainless steel pins to reinforce the heavier sections.

The seascape panel had a clean break and was glued together using stone resin. Its ceramic walls were too thin to be safely drilled for reinforcing pins - a slot was cut in each side and a stainless steel dowel glued into it to act as a splint.

Reconstruction was carried out in stages over the summer to allow the lime mortars to gain an initial set before each step of the process. Bathstone replacements for the four destroyed plinth sections were cut and worked with corresponding mouldings. Two other sections were repaired with stone resin and a third with lime mortar. The site of the pier was cleaned and the four intact plinth sections remaining in situ were cleared of rubble. The plinth was rebuilt with hydraulic lime mortar up to the first course of brickwork and back filled with limecrete to a depth of 400mm. This was then allowed to take an initial set for three weeks before the construction of a lightweight concrete block core. This was designed to replace the original flint rubble core which proved vulnerable to impact. It also hastened the build, bypassing the need for a prolonged lime setting period. Stainless steel ties held the ceramic sealife panels in position relative to the core and the brick courses built around these, again bedded on a hydraulic lime (NHL 3.5) mortar. On completion of the topmost brick course a period of four weeks was allowed before the fixing of the capstone. This was craned into position in early October and final mortar repairs to the damaged terracotta detailing completed the process.
