Poole Park Tree Strategy – 2017-2021 and beyond

5.30pm – 6.30pm Poole Park Tree Strategy

Future Tree Strategy – Issue 1

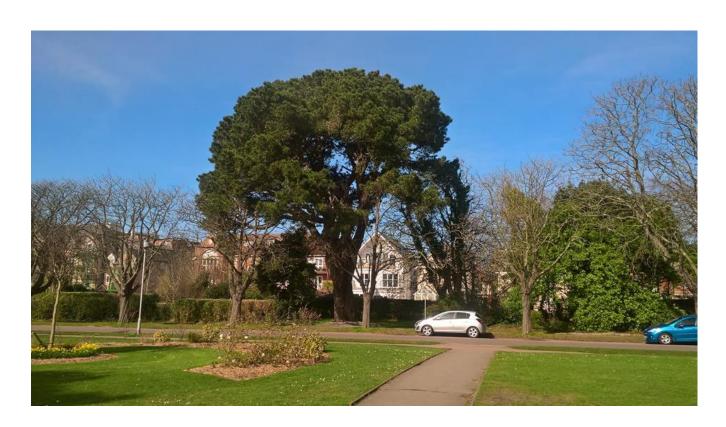
Monterey Pine (T182) (photo below) is situated along the boundary opposite the Ark Café. This is a locally notable tree of nearly 5 metres in girth. It is estimated that the tree is around 150 years of age. The tree has a large canopy and is visible from some distance away. Over time, the tree canopy has expanded over the horse chestnut avenue causing suppression of these trees to the point where they are now not worth retaining.

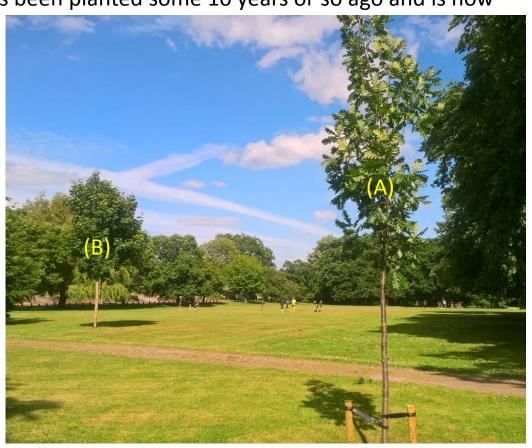
Trees will be specified at a girth of 18-20cm or 20-25cm (nursery measurement). The photo below shows a tree in the foreground (A) that was planted within the last 2-3 years and is still at nursery size. This is the size of tree we are proposing to plant and should resist casual vandalism.

The tree in the background (B) has been planted some 10 years or so ago and is now

nicely maturing.
