## FINAL REPORT

# Poole Park Lakes: Research and monitoring

**BUG REFERENCE:** BUG2710

Client:  
**Borough of Poole**  
1 New Fields Business Park  
Stinsford Road  
Poole  
Dorset  
BH17 0NF

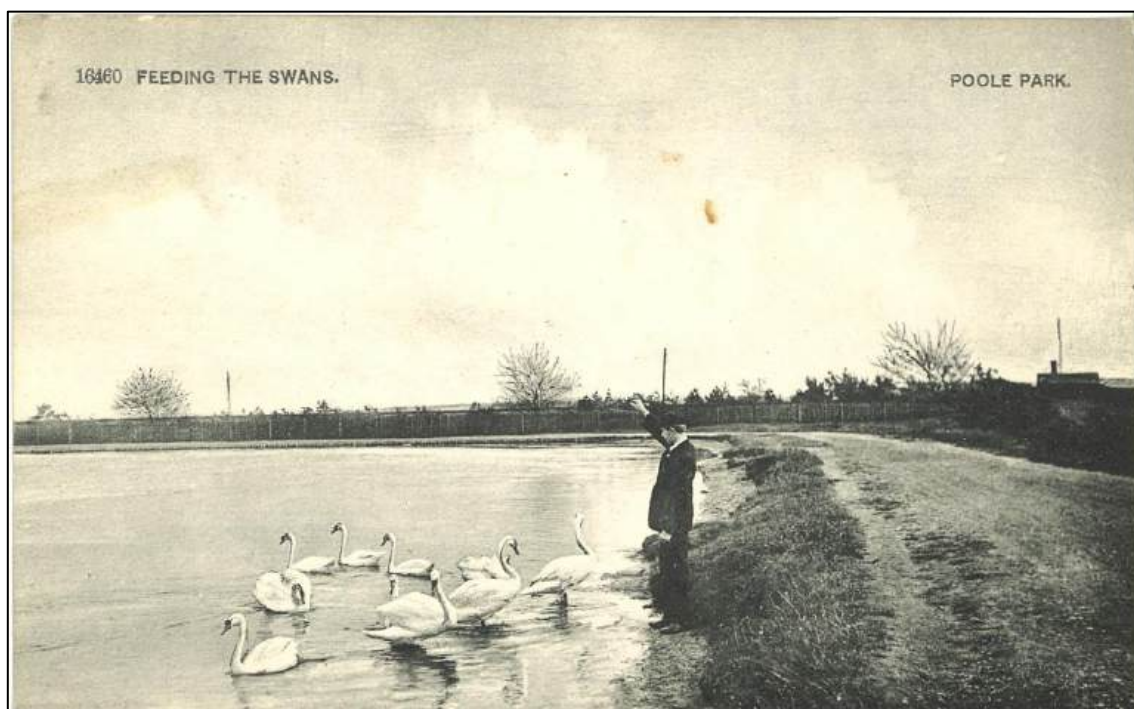
**Figure 1.1 The southwest corner of the impounded Lagoon during the early 1900's. Note the lack of hard bank engineering and presence of natural sloping beach habitat.**

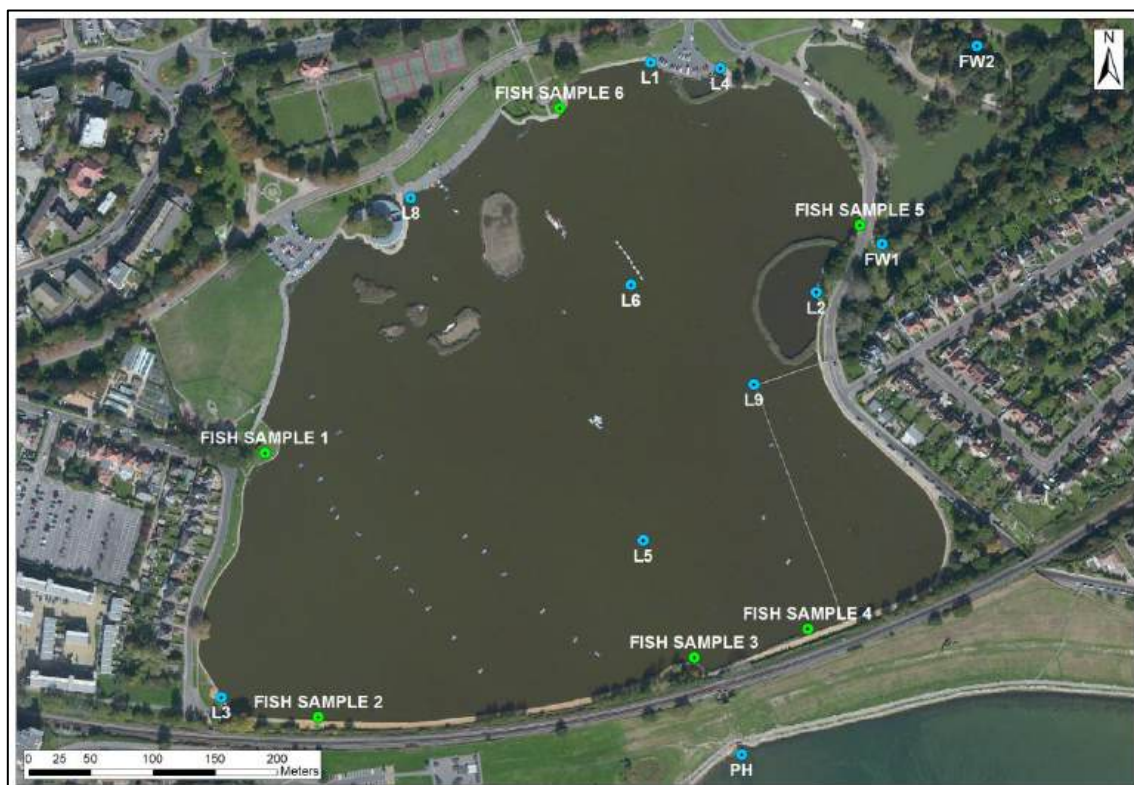
**Figure 3.1** Sampling locations for the 2015 environmental monitoring programme. Blue circles = water quality, sediment quality and invertebrate samples. Green circles = fish samples.

Fish surveys were conducted at six marginal locations, identified in Figure 3.1. Sediment samples were collected from L1 to L6, FW1 and FW2, and benthic invertebrate samples were collected from L5, L6, FW1 and FW2.

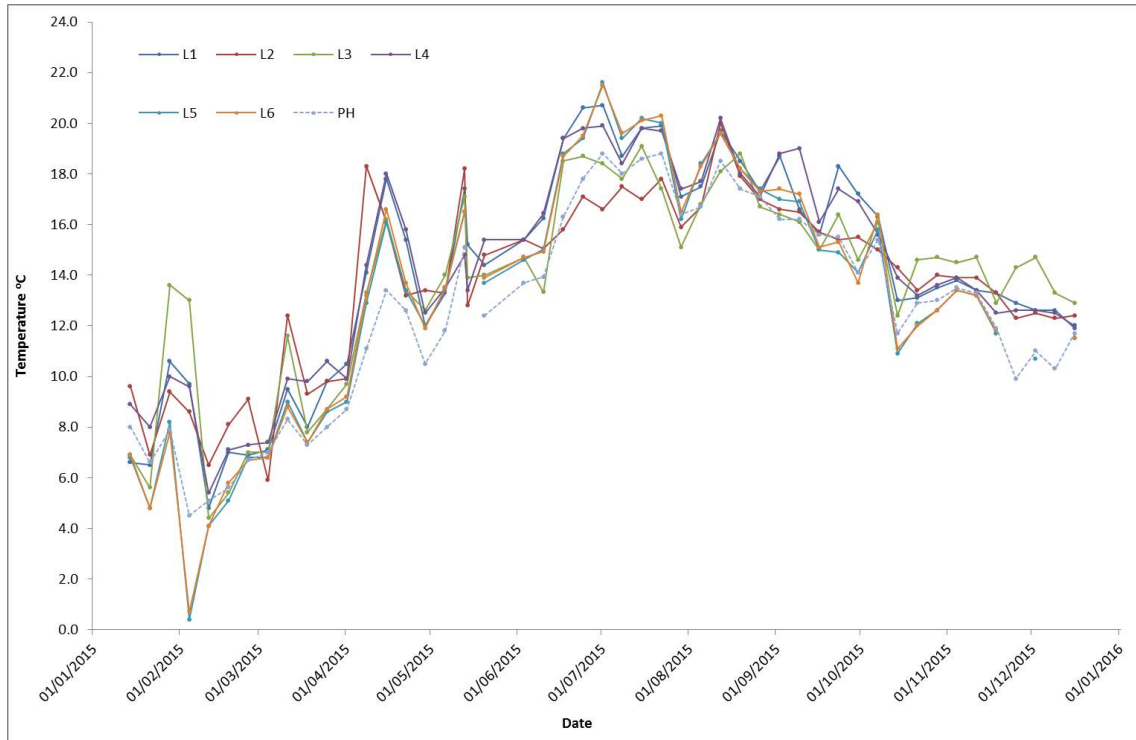
**Figure 4.1 Temperature at Lagoon locations L1 to L6 and Poole Harbour location PH.**

Temperatures of the Lagoon drain input locations L1 to L4 varied more widely than in the main lagoon locations L5 and L6. Most notable was the significantly higher temperatures recorded at drain input location L3 during January and February (12 - 14°C) compared with the main lake (Figure 4.1); during this period, steam could be seen rising from the open water surface in the vicinity of the L3 input, at a time when the majority of the remainder of the water surface was frozen (Figure 4.2).

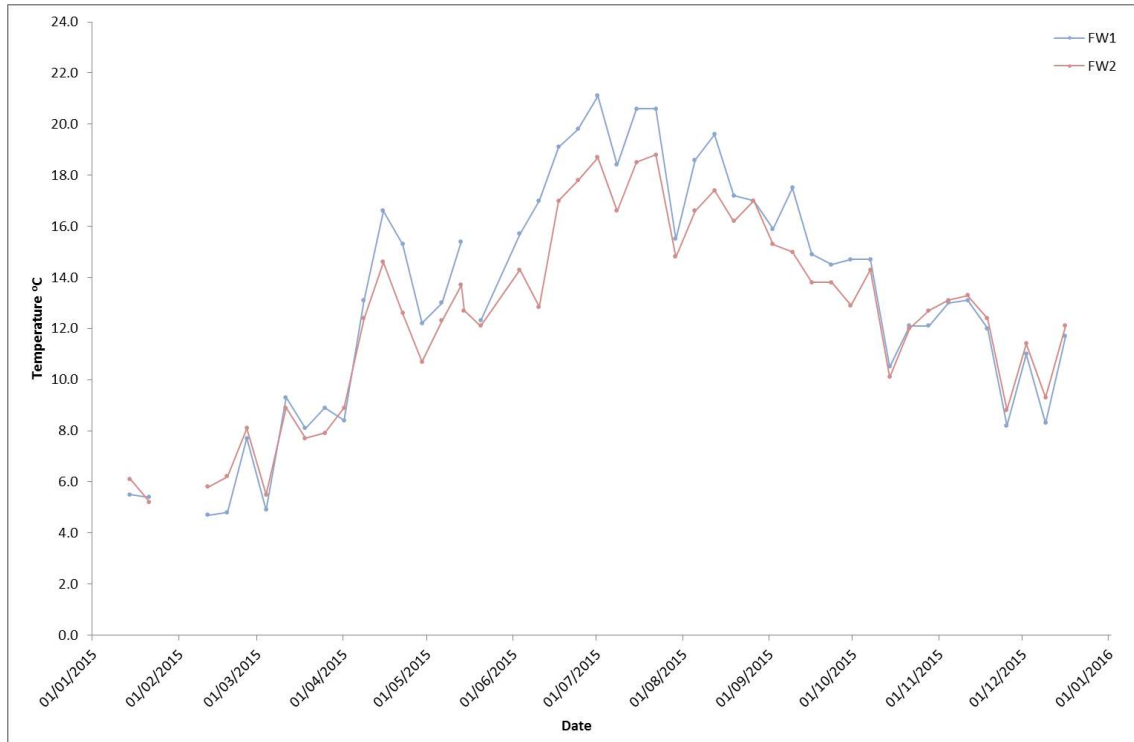
**Figure 4.3 Temperature at freshwater lake locations FW1 and FW2.**

The larger freshwater lake (FW1) was typically 2 - 3°C higher than the smaller freshwater lake (FW2) during the summer months (Figure 4.3). This could potentially be explained by the much higher degree of shading by overhanging trees at FW2 compared with FW1.

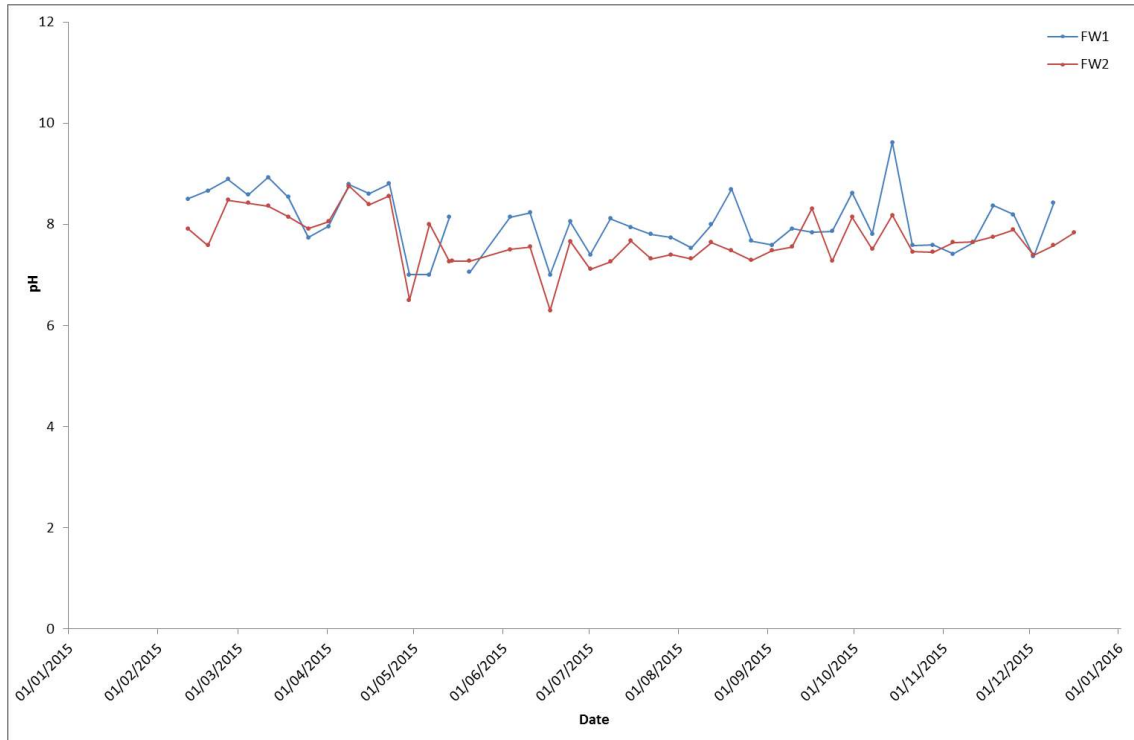
**Figure 4.7 pH at freshwater lake locations FW1 and FW2.**

Freshwater lake locations FW1 and FW2 exhibited broadly similar pH ranges, generally ranging from 6.5 to 9 (Figure 4.7).

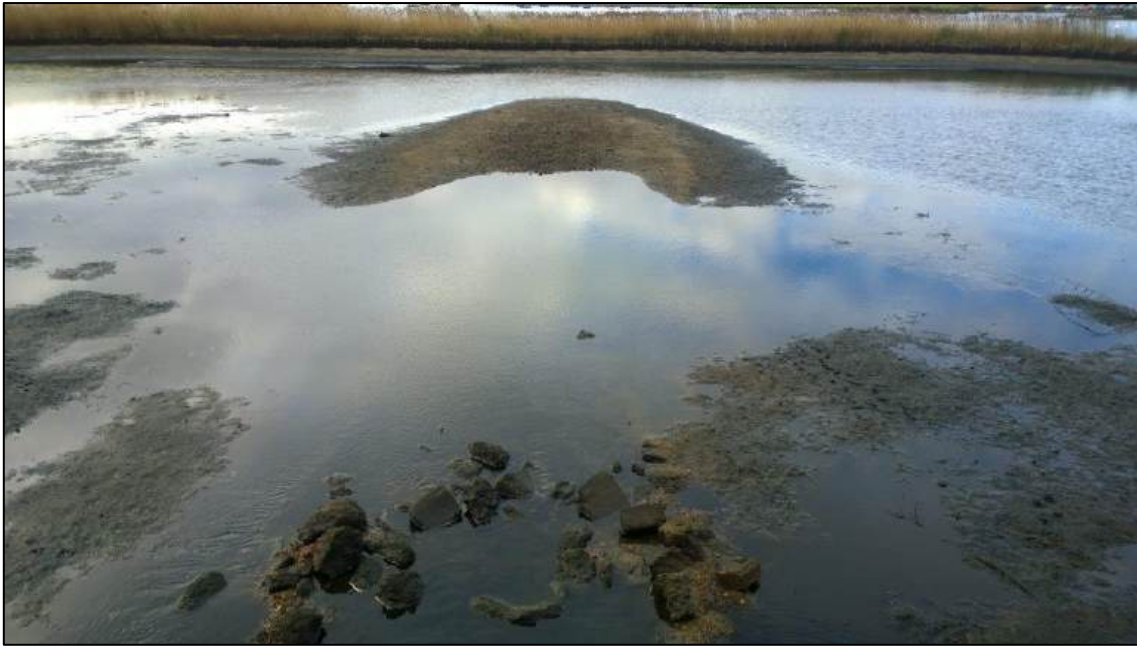
**Figure 4.27 Evidence of suspended solid input and lake bed scouring at L2 during a drain down.**

Lagoon drain input TSS loads varied considerably, in response to rainfall events, surface run-off and sewage treatment works discharges (Figure 4.26). Evidence of TSS inputs and lake bed scouring at Lagoon drain input L2 (the largest input by volume) can be seen in Figure 4.27.

Total suspended solids were generally low throughout the year in the Lagoon at L5 and L6 (Figure 4.25). However, high loadings were evident at all of the drain inputs, particularly at L2 which delivers high volumes of surface water run-off and also receives water from a Combined Sewer Overflow (Figure 4.26 and Figure 4.27).

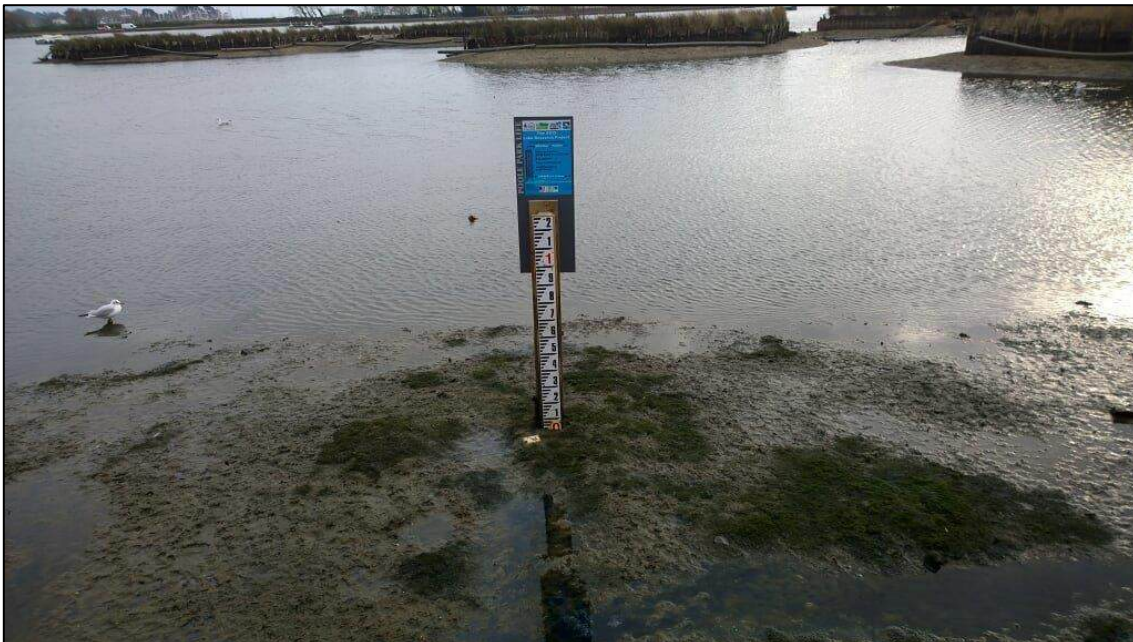
**Figure 6.1 Gauge board installed in the Lagoon adjacent to The Kitchen restaurant. Photo taken at low water level during a drain down (lake full water level ~0.7 mAOD).**

Two gauge boards were installed in the Lagoon; one adjacent to The Kitchen restaurant (Figure 6.1) and one on the lake side of the sluice gate (Figure 6.2). Both gauge boards were levelled to mAOD. In addition, a metal plate was installed on the Poole Harbour side of the sluice gate, which was also levelled to mAOD.

Gauge boards were read on each survey visit by the BUG field team. In addition, as part of the public engagement strategy, members of the public were encouraged to take photos of the gauge board adjacent to The Kitchen restaurant and post them to a dedicated Facebook group page (Section 7.4).

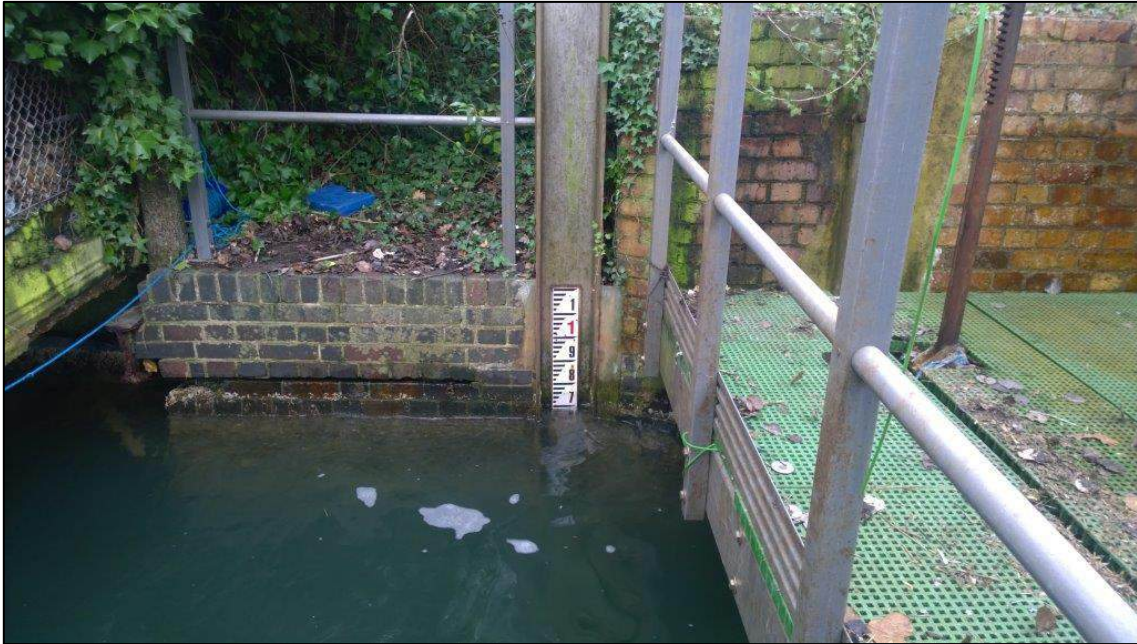
**Figure 6.2 Gauge board installed in the Lagoon adjacent to the sluice gate. Photo taken at lake full water level.**

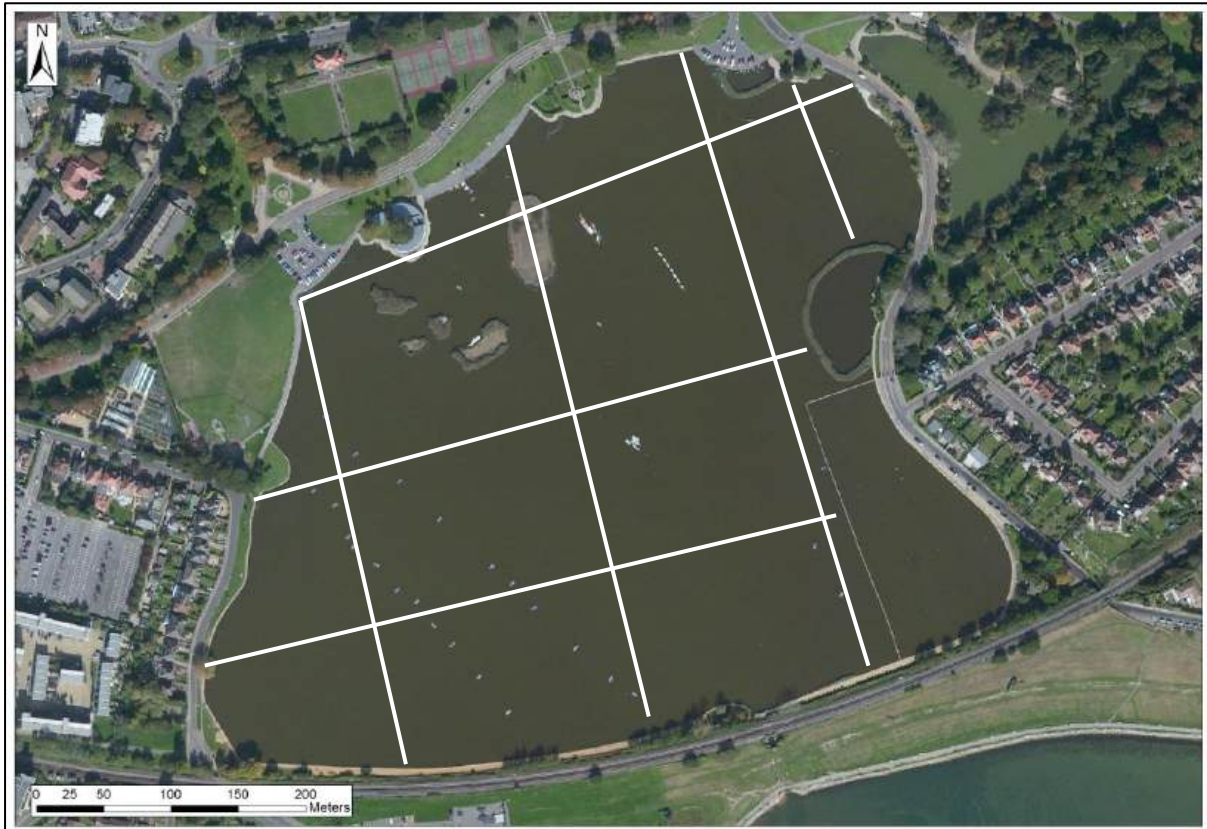
**Figure 6.5 Transect locations for sediment depth data collection.**

Sediment depth profiles of the main lake were recorded during a two day survey commencing 3<sup>rd</sup> January 2015. A total of seven transects across the lake were completed with a total of 136 depth recordings taken (Figure 6.5). At each sampling location, sediment depth was measured using a gauging pole and the location recorded using GPS.

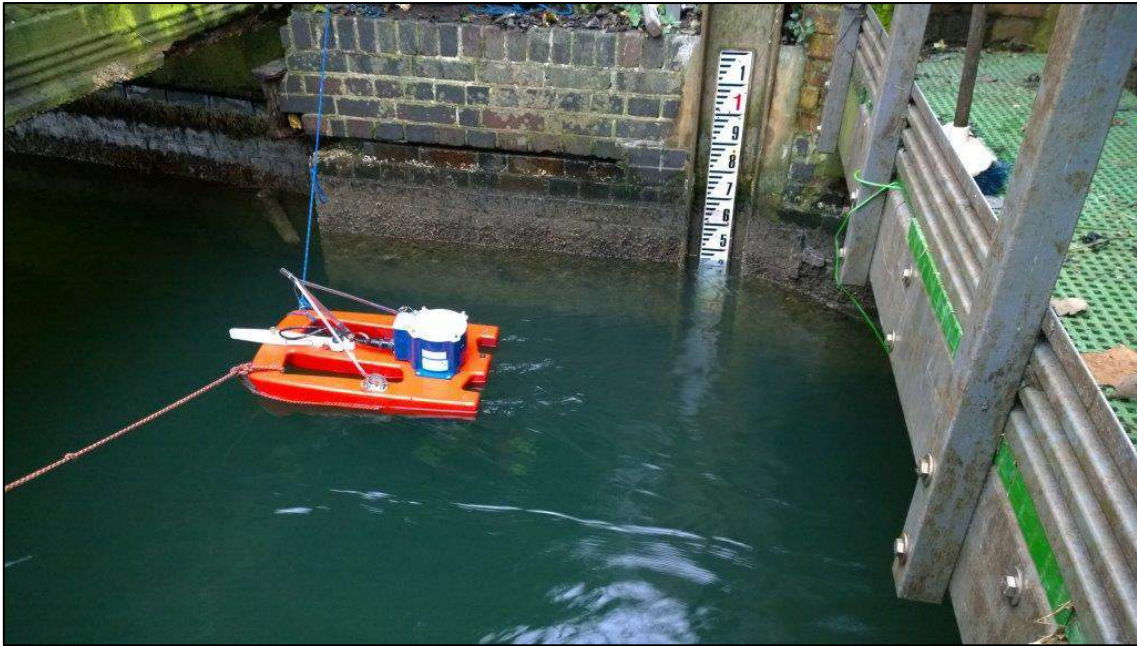
Figure 6.7 Flow gauging at the sluice gate being conducted over the full period of a lake drain down using an Acoustic Doppler Current Profiler (ADCP).

To determine the rate of volume exchange during a drain down event of the Lagoon, a Teledyne RDI StreamPro Acoustic Doppler Current Profiler (ADCP) was used to directly measure velocity ( $\text{ms}^{-1}$ ) and discharge ( $\text{m}^3\text{s}^{-1}$ ) through the sluice gate (Figure 6.7).

Transect measurements across the channel were recorded every 30 minutes throughout the entire period of lake drain down.

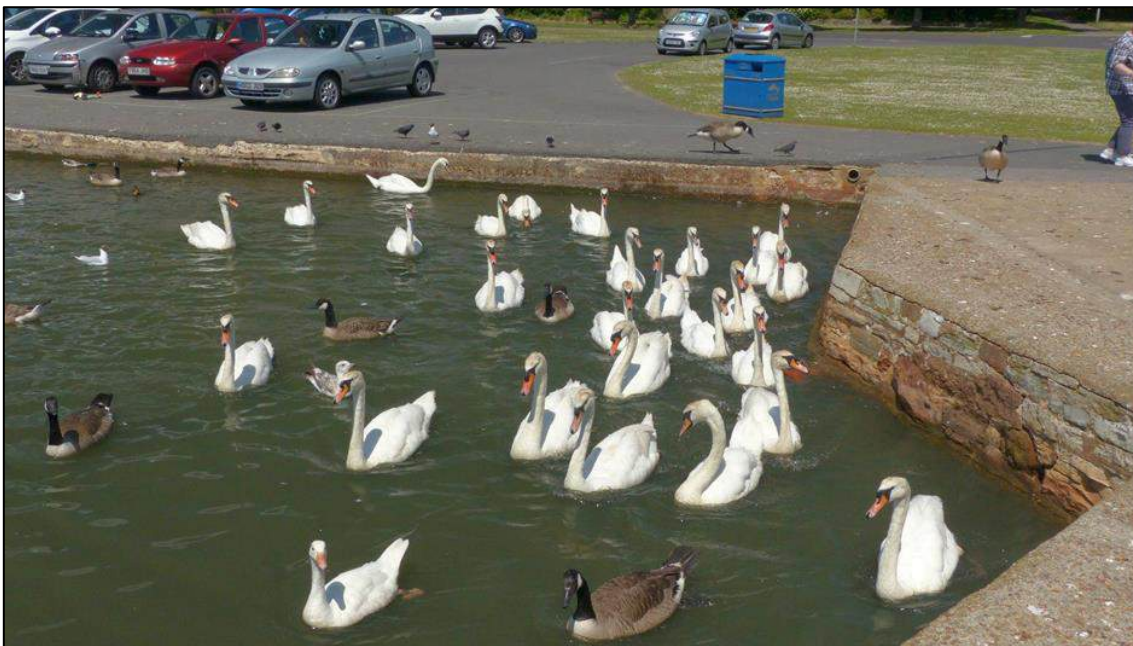
**Figure 8.2 High numbers of birds (due to feeding by the public) in the vicinity of L4.**

Both phosphorus and, particularly, nitrogen levels were elevated at Lagoon drain input L4. This is most likely a direct result of extremely high numbers of birds being fed at this location beside the car park (see Figure 8.2).

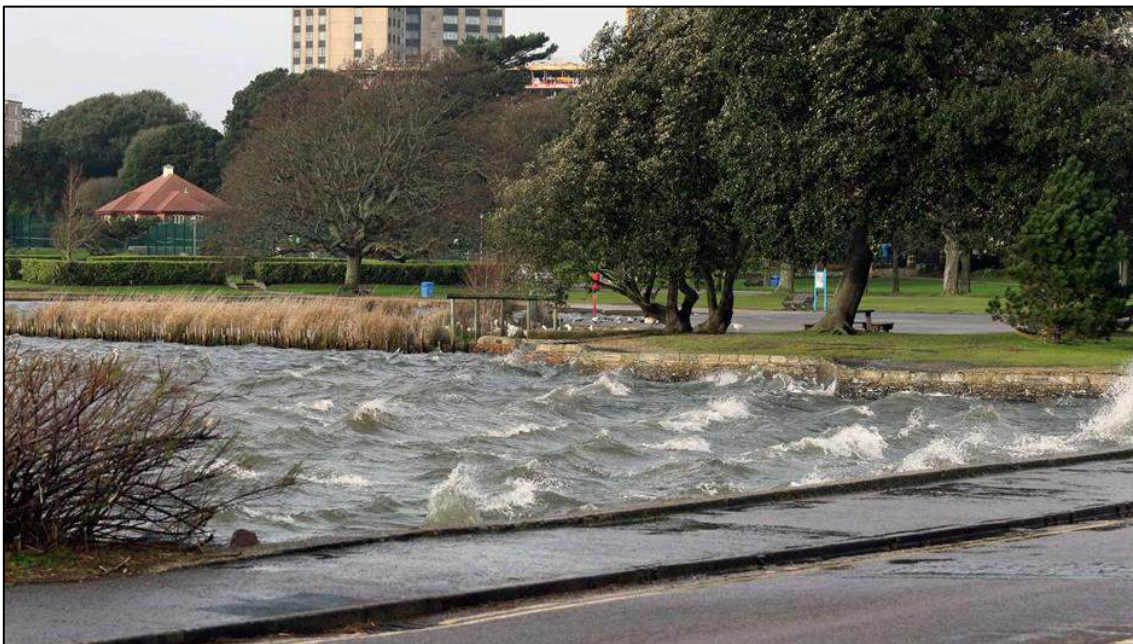
**Figure 9.1 High south-westerly winds creation wave action on the north-east shore due to the large reach across the main body of the Lagoon.**

In addition, creation of new islands in the north-eastern area of the Lagoon would also help to reduce the impact of wave action on the northern banks during periods of high winds from the prevailing south-westerly direction (Figure 9.1).

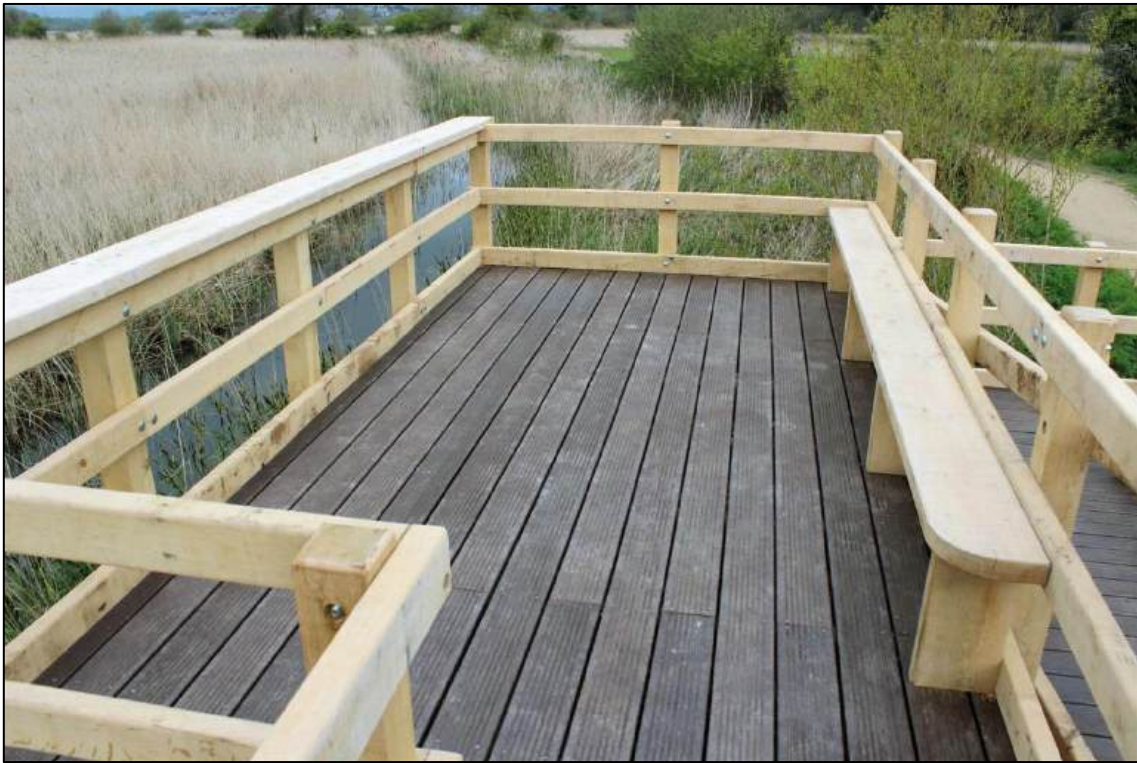
**Figure 9.3 Decked boardwalk at Radipole Lake in Weymouth – a children’s crabbing area for the Lagoon in Poole Park?**

Enhancing the accessibility of the Lagoon through the creation of submerged islands and boardwalks may also shift the focus from bird feeding in the freshwater lakes, which contributes to the degraded water quality and nuisance geese in these areas. For example, creation of a deeper 'crabbing' zone on one of the islands would provide additional activities for young families to enjoy (Figure 9.3).

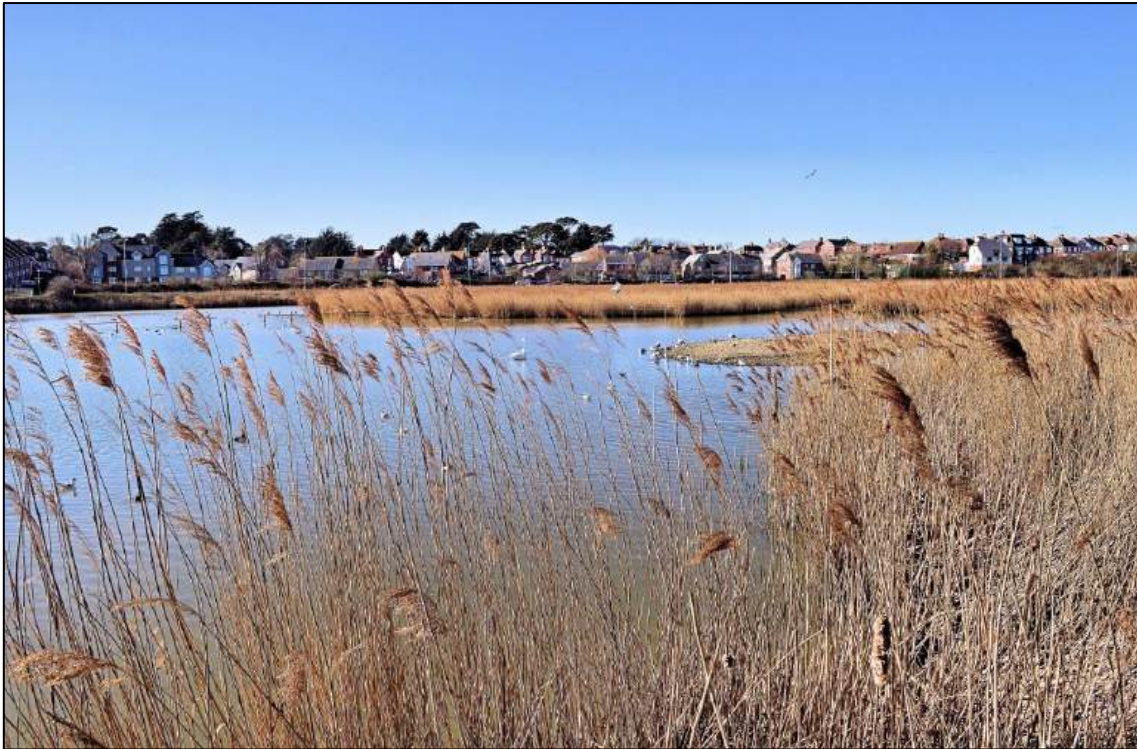
**Figure 9.4 Radipole Lake in Weymouth – an example for the Lagoon in Poole Park?**

Although considerably larger than the Lagoon and subject to a range of different environmental conditions, Figure 9.4 below shows a photo of Radipole Lake in Weymouth and illustrates the type of habitats that could be created in the Lagoon. In particular, gravel shoals and submerged reedbed islands with shallow depth profiles offer foraging habitat for wading birds, and provide refuge for a range of species.
