VICTORIAN BUILDINGS IN POOLE PARK

THE BRICK AND TERRACOTTA STRUCTURES WITHIN POOLE PARK

*CONSERVATION CONDITION SURVEY, REPORT AND
RECOMMENDATIONS FOR CARE*

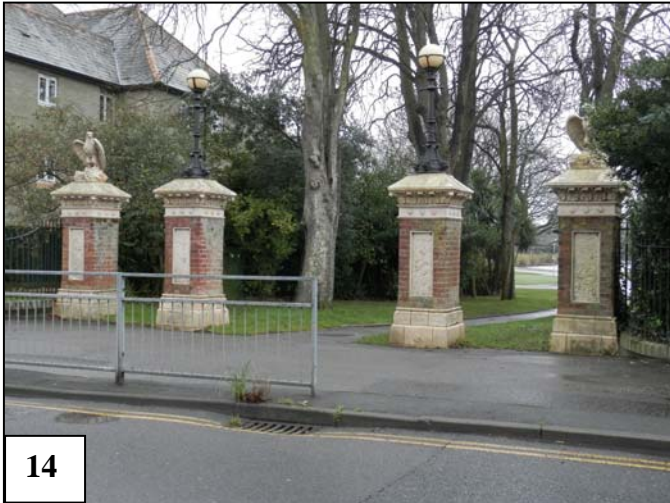
At first glance the piers seem to be in reasonable condition. Despite the turfed area extending to and nearly surrounding the bases, there is limited discolouration from biotic growth, although the most westerly pier is succumbing to ivy invasion because of its proximity to the hedging/shrubbery. There has been previous re-pointing of the brickwork with a cement mortar which, although not causing serious salt decay to the adjacent bricks, is unsightly. There is some damage/loss of material to the terracotta detailing both on the plinth blocks and the capstone decoration. Joints on the capstone have suffered from loss of pointing material. Several of the cast iron hinge and bracket (sic) fixings have been left in situ, some have been cut off flush to the brickwork (presumably to avoid injury to pedestrian users of the centre opening).

- 14. MIDDLE GATE VIEWED FROM PARKSTONE ROAD
- 15. DAMAGE TO THE CORNER OF THE TERRACOTTA DETAILING AND LOSS OF POINTING MORTAR ON THE CAPSTONE
- 16. DAMAGE TO THE MOULDINGS ON THE TERRACOTTA PLINTH BLOCKS
- 17. INVASIVE IVY ON THE WESTERNMOST PIER

Initial work should involve the re-pointing of the perpendicular capstone joints to reduce potential water ingress. Damage to the terracotta detailing could be repaired using a hydraulic lime mortar on armatures, mixed to colour match the substrate material. There is a reasonable case for the removal of the cement pointing on the brickwork and its replacement with a suitable lime mortar but extreme care would need to be taken to avoid damaging the bricks in the process. All remaining iron work should be cleaned and treated with a rust inhibitor but left in situ if deemed to be non hazardous to the public. Consideration should be given to the removal of turf from, and paving of, the areas on the Park side of the piers. This would reduce the risk of water saturation around the bases, it would reduce the risk of damage from grass cutting/trimming equipment and may enhance the piers' appearance. Limited biocidal cleaning could be considered.

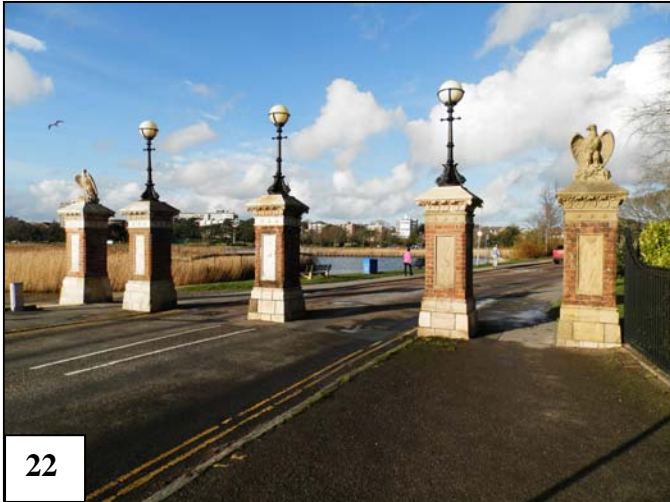
Despite their close proximity to the salt water of the boating lake, the gate piers show little evidence of salt decay in the brickwork. As with the other gates, loss of jointing mortar is an issue, both on the ceramic work and in parts of the brickwork. There is evidence that the narrow carriageways have resulted in damage to the plinth blocks from vehicle impact. Marine environment plants have rooted themselves around some of the capstones and there is lichen growth on some of the capstone pieces. The remaining ironwork is, as with the other gates, random and without any obvious reference to its original purpose. The C20th work obviously substituted different materials for a number of elements – although there appear to be original ceramic sections alongside recent replacement terracotta pieces - resulting in something of a patchwork effect in some of the detailing. Other composite (concrete) replacements are of a very different texture and mineral composition to the remaining original terracotta work, resulting in mineral discolouration and the accumulation of pollutants in their more porous surfaces.

22. VIEW FROM THE SOUTH, SHOWING THE NOW REBUILT WESTERNMOST PIER
 23. PLANT GROWTH ESTABLISHED IN THE CAPSTONE JOINTING
 24 AND 25. CLEAR VISUAL DISCREPANCY BETWEEN REPLACEMENT TERRACOTTA AND CAST CONCRETE/COMPOSITE ELEMENTS

Re-pointing of failed joints and inappropriate mortar should be carried out. Some repair work to the terracotta could be undertaken. Plant and growth removal with appropriate biocidal treatment is recommended. Consideration should be given to restricting vehicle speed through the entrances to minimise the risk of minor collision with the piers. Unfortunately the options for minimising the discordant appearance of the former restorative work are limited and it should be viewed as honest evidence of these previous interventions.

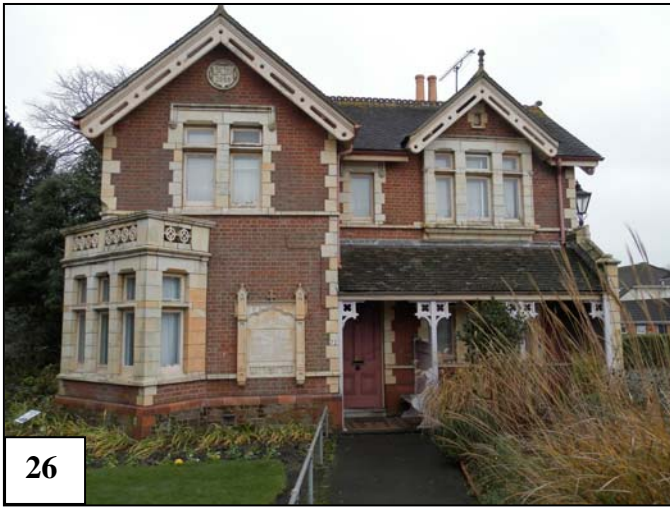
Overall, the lodge appears to be in relatively sound condition (this report cannot attest to its structural integrity). The most significant details (the commemorative plaque and the armorial) are in good condition with no damage or staining. There is disruption and loss of bedding and pointing mortar on the joints of the corner bay parapet, the SW corner quoins and the stable yard gate piers. There is no visible evidence of settlement, jacking or stress in the former, in the case of the latter there is evidence of vehicle damage to the glazed brickwork plinth and plant growth disruption around the capstone. There is some plant growth from the base of the N chimney pots. The south gable elevation has relatively recently been re-pointed with a cement mortar that appears to be performing well. An unsightly void and radiating cracking in one of the SW quoins has possibly been caused by the past insertion of a ferrous? fixing.

- 26. WEST ELEVATION OF THE LODGE
- 27. ARMORIAL ROUNDEL ON THE SOUTH ELEVATION
- 28. TERRACOTTA STIFF LEAF LABEL STOP
- 29. PARAPET OVER CORNER BAY SHOWING OPEN PERPENDICULAR JOINTS BETWEEN COPINGS

Removal of any failed pointing and re-pointing with an appropriate lime mortar (see Specifications Section 15). Any plant growth should be removed and any inaccessible root systems treated with systemic weedkiller. The caps and finials on the stableyard gate piers should be checked for stability. Loose elements should be removed, cleaned and re-set in lime mortar. The parapet above the corner bay should also be checked for stability and loose elements re-set as above. Any holes/excavations in the terracotta work should be filled with colour matched mortar. Re-decoration of the cast iron rainwater goods and timber elements would benefit the appearance of the building and help prolong their integrity and that of the surrounding materials.

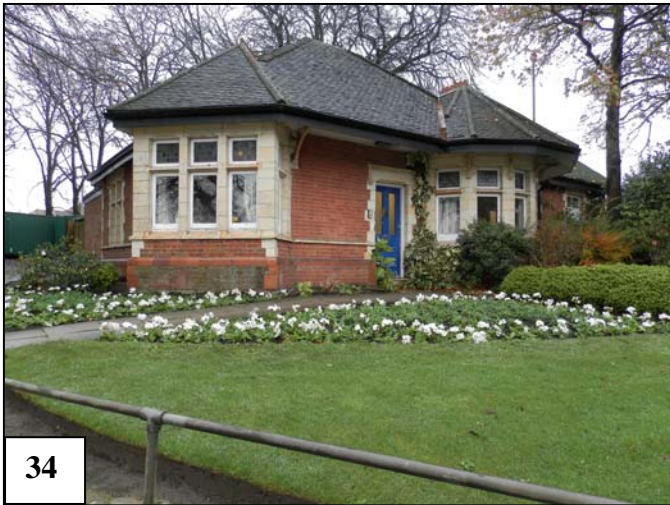
The building is in relatively good condition and has been by no means neglected. It has however been allowed to shrink from prominence, mainly because of unsympathetic alteration and, currently, excessive plant growth around the east and north elevations (the inscription panel is almost obscured from view). Dense growth around the canted bay window and soil levels rising above the air bricks may prevent adequate ventilation and impede drainage away from the walls (ivy, although not directly harmful to the brick surfaces, can invade joints where pointing has failed or between timberwork and eventually cause expansion damage). There is loss of facing on many of the (newer) bricks on the west extension. There is unsightly damage to the weathering underside of the terracotta sill on the south window (due perhaps to frost or impact). On the north elevation some of the terracotta plinth weathering course is missing. There is considerable loss of mortar around the joints of the inscription panel and the surrounding window and some slight cracking to the surface of the panel itself. Jointing between the timber window frames and the terracotta surrounds has failed in some windows and been replaced by scrunched up paper. The rainwater goods appear in good condition. Paint work on the soffits is badly deteriorated with extensive blistering and peeling. There is some slight distortion of the leaded lights on the bay windows.

- 34. VIEW FROM THE SOUTHEAST
- 35. NORTH ELEVATION WINDOW AND COMMEMORATIVE INSCRIPTION PANEL
- 36. FAILED MORTAR IN JOINTS AROUND THE INSCRIPTION PANEL
- 37. SUBTLE USE OF PAPER AROUND WINDOW FRAMES
- 38. DAMAGE TO WINDOW SILL ON SOUTH ELEVATION
- 39. EXCESSIVE PLANT GROWTH AROUND CANTED BAY WINDOW

A programme of re-pointing all failed joints should be considered. Damaged bricks and terracotta work would benefit from limited repair in matching lime mortar. Plant growth around the north elevation and underneath the east bay window should be cut back, the soil level lowered and appropriate drainage considered. Some care should be taken to clean and repair the fine cracking on the inscription panel and consideration given to clearing the plants obscuring it from view. A programme of paint re-decoration should be considered for the timber elements including window frames, soffits and corbelled brackets around the canted bay.

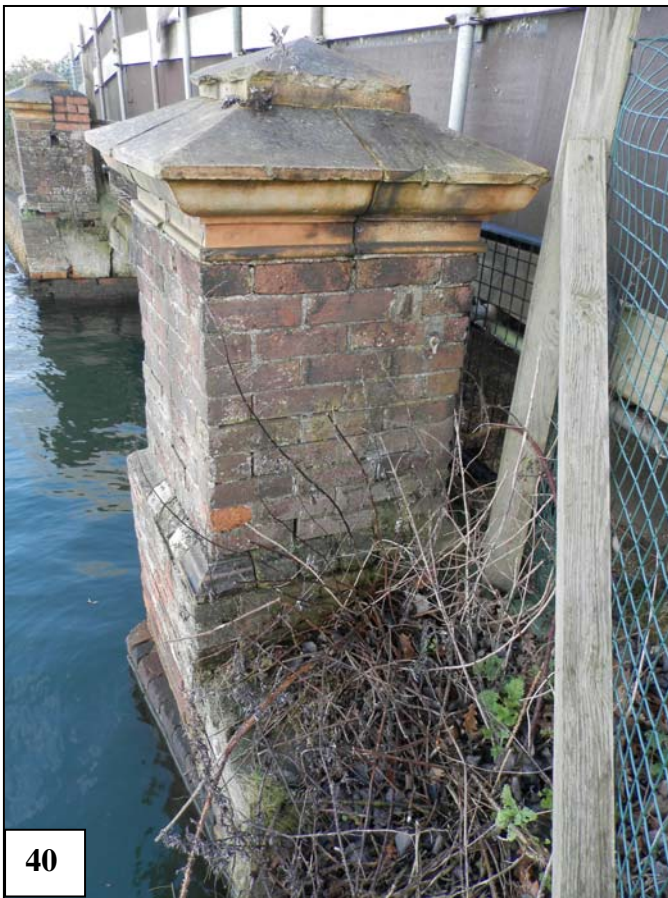
40. THE WESTERNMOST PIER

The piers are in poor cosmetic condition and may have some structural issues. Their appearance is not enhanced by the unappealing railings of the footbridge behind and the overgrown banks and old fencing to the sides. There is considerable loss of jointing mortar on both, especially at lower (water) levels and some missing and loose bricks on the easternmost pier. Concrete rendering at water level is cracked and may be detaching. Original hinge locations are now unsightly holes. The cappings on each consist of five sections and pointing has failed on most joints allowing water ingress to the core. One section of capping on the east pier is missing and has been replaced with a completely mismatched brick and render repair (which does appear to be structurally sound). There is considerable plant growth around both piers and it is likely that root systems have invaded the cores of both.

More investigation into the integrity of the piers is advisable. The loss of the gates themselves has probably lessened the stresses imposed but repair work should only proceed if the piers are deemed to be structurally sound. All plant growth should be removed and the piers treated thoroughly with an (environmentally suitable) biocide. Repair or replacement of render and pointing at and below water level should be carried out using a natural cement. Other failed brick work mortar should be re-pointed with an eminently hydraulic lime mortar (NHL 5). The capstones should be re-pointed and cleaned and consideration should be given to replacing the missing section on the east pier with either a cast ceramic or stone substitute. A comprehensive risk assessment must be undertaken before any further work on the piers.

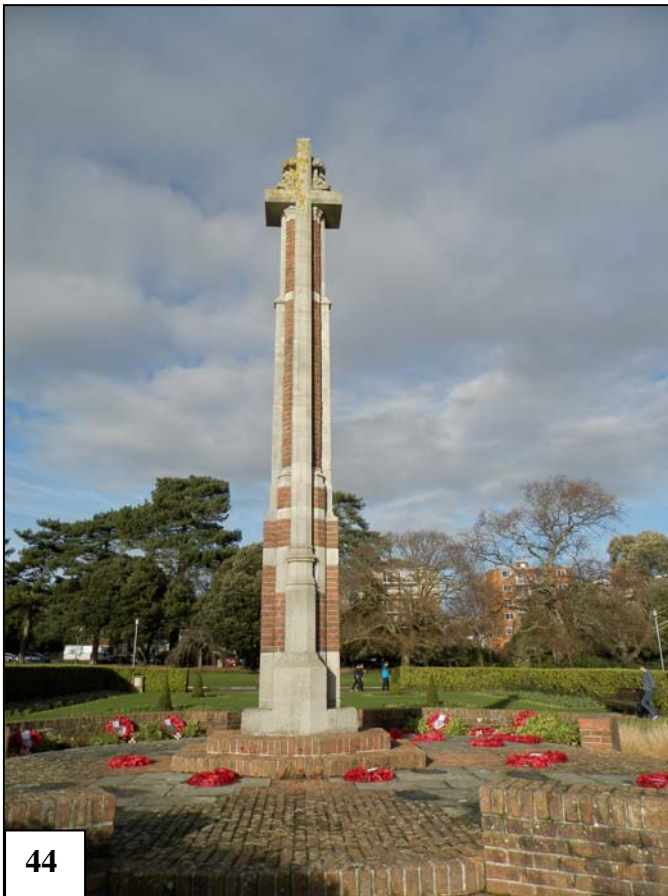
The Memorial obelisk is in reasonable condition given the coastal environment. There is some slight loss of pointing mortar on the brick work (mainly at the corner arrises) and on a few of the stone joints. As would be expected there is little pollutant staining but there is considerable lichen growth on the stonework at the top of the cross, where there also appears to be a slight area of damage to the end of the west horizontal member. There is a severe fissure across the north of the brick terrace, the hard cement grouting/pointing causing the bricks as well as the joints to crack. This may be due to some slight settlement but there is nothing to indicate major disruption. A smaller fracture can be seen just to the south of the podium steps. The brickwork around the Memorial is in reasonable condition but there are some areas of lost pointing. The flag and crazed paving is unsightly but not in poor condition.

- 44. VIEW FROM THE SOUTH (LAKESIDE)
- 45. VIEW FROM THE NORTH (INSIDE THE MEMORIAL GATES)
- 46. LICHEN BUILD-UP AROUND THE TOP OF THE CROSS (SLIGHT STONE DAMAGE ALSO VISIBLE)
- 47. CRACKING ACROSS THE BRICK TERRACE (NORTH END)

Normally one would advocate as little invasive cleaning as possible and the Memorial is not greatly stained or discoloured but it may benefit from a benign steam based cleaning programme such as the Thermotech or Doff processes. This would remove the unsightly lichen and restore brightness to the Purbeck stone. Limited re-pointing should be undertaken to the obelisk shaft and cross with care taken not to damage brick and stone arrises during the removal of old mortar. Any damage to the Purbeck stone should be repaired using a matching hydraulic lime mortar. The brick terrace may also benefit from cleaning using the same steam based method as the cross and again careful re-pointing is recommended. Any fractured bricks should be removed and replaced with a durable and suitable match. It is not within the scope of this report to advise on the aesthetic of the subject but it is debatable whether the landscaping around the Memorial suitably enhances its intended impact.

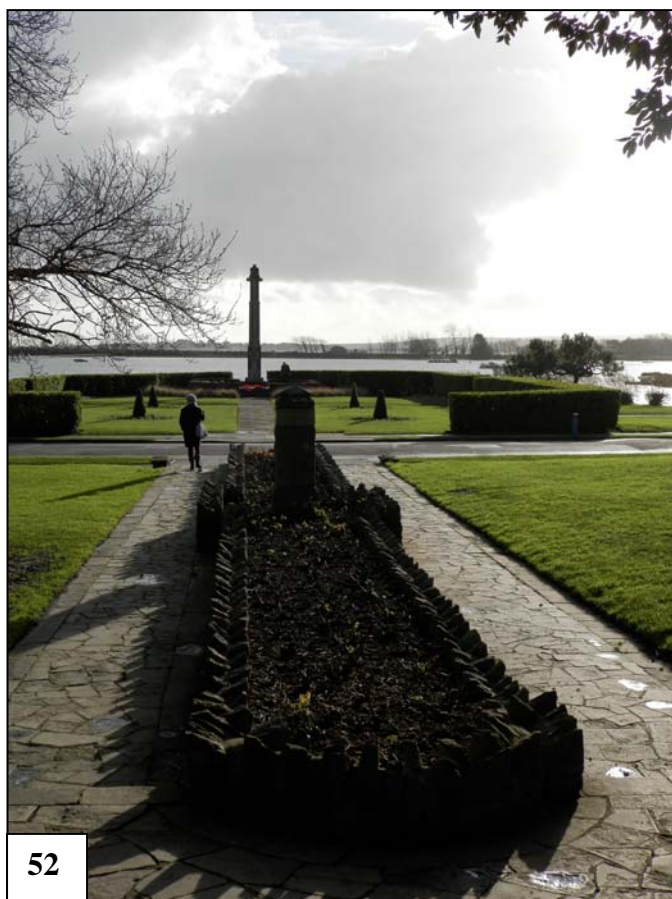
52

From a conservation point of view, the bed and memorials are in good condition (the use of cement mortars having little detrimental effect on the stonework thus far).

52. VIEW SOUTH ALONG THE ROSEBED TOWARDS THE WAR MEMORIAL
53. THE MOUNTBATTEN OBELISK

A consensus suggests that the dogtooth 'copings' are at least unsightly and at worst unsuitable for a memorial and, as later alterations, are questionable as worthy of the Park's listed status. Although outside the scope of this report, consideration could be given to their replacement with a more aesthetically appropriate design in keeping with the reflective atmosphere of the Memorial 'avenue'.
